RAN A4G Night ramp strike story — a series of notes and images, added over a year or so — explains various points about this event — 01 September 1971

Ramp Strike aboard HMAS Melbourne 01 Sept 1971 – Phil Thompson

Aftermath from night DL 01 Sep 1971

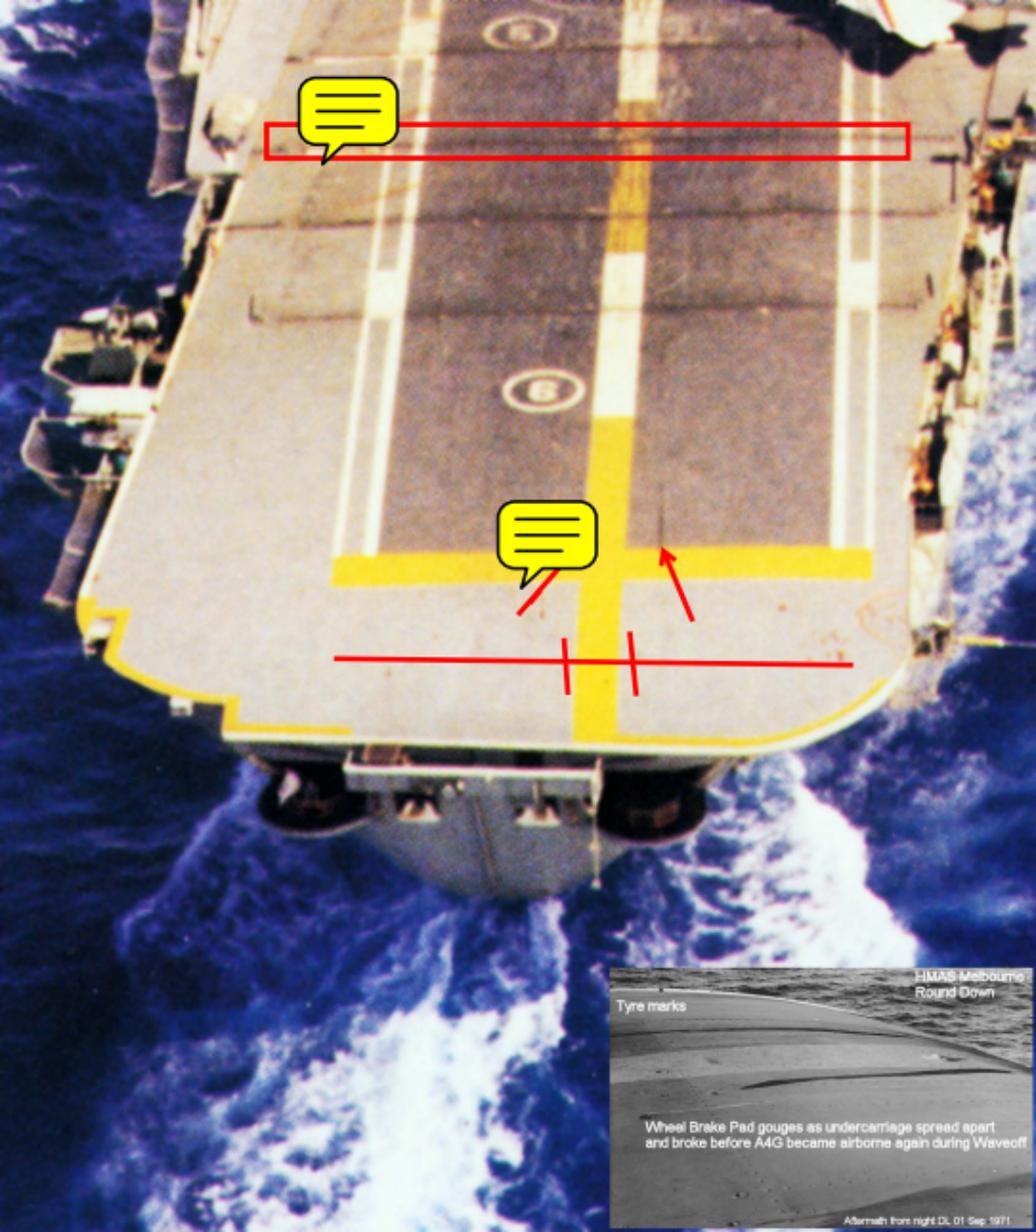
HMAS Melbourne Round Down
Tyre marks

Wheel Brake Pad gouges as undercarriage spread apart and broke before A/G became airborne again during Waveoff

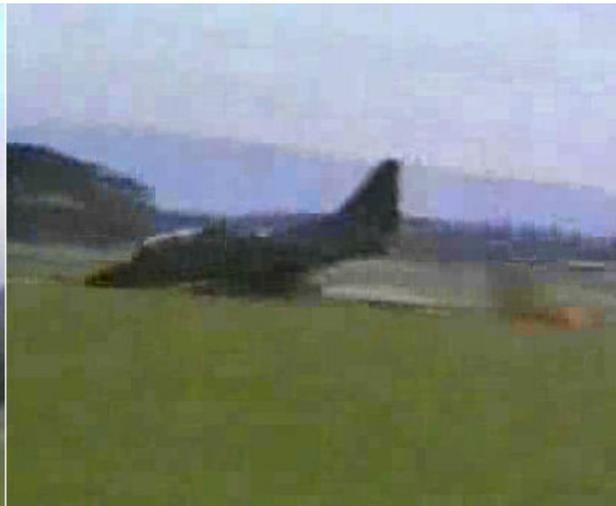
Incident Sep 1989 Ohakea - touched down short of threshold losing starboard main u/c — arrested landing on drop tanks. The right screenshot shows the arrestor gear on runway, then the left screenshot shows the flash of fuel vapour at end of rollout.

This also happened at night in my similar arrested landing (after ramp strike) but in both cases the fire did not persist. That flash had me hopping out 'real quick'. :-). At the end of the runout as the pilot suggests in the commentary (not on this clip) there is a "small fire" (flash) as the fuel vapour in the empty drop tanks ignites at the end of the runout.
