DEPARTMENT OF DEFENCE
DEFENCE SCIENCE AND TECHNOLOGY ORGANISATION
AERONAUTICAL RESEARCH LABORATORIES

Aero Propulsion Report 175

REPORT ON GAZELLE ENGINE SEVENTH
STAGE COMPRESSOR BLADE FAILURE

D. E. GLENNY

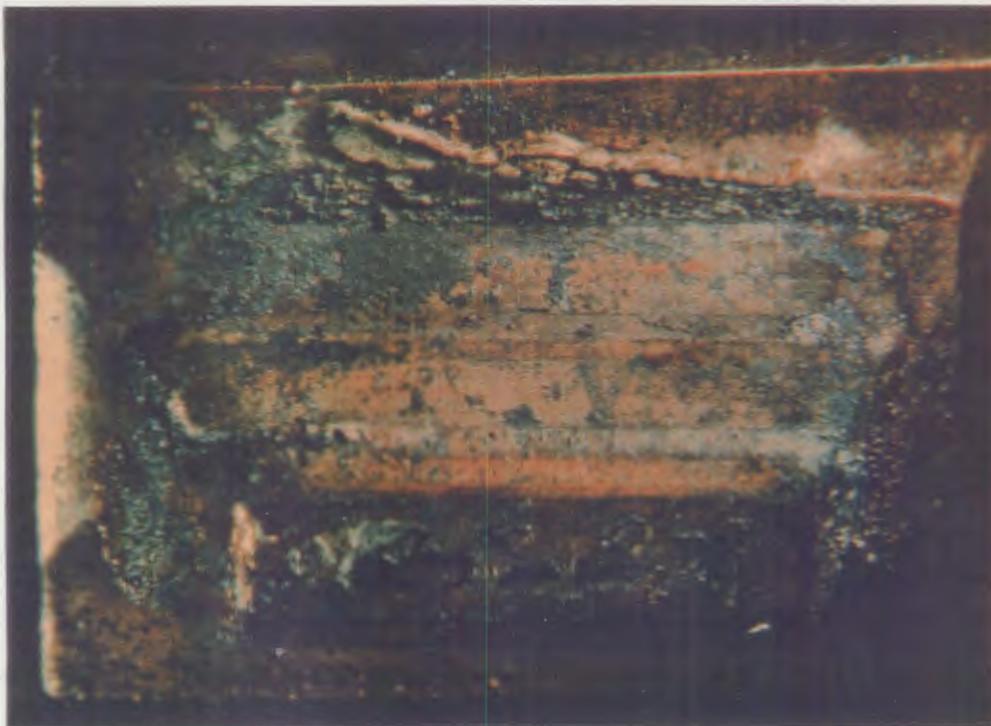
At the time of the Rolls Royce investigation, Rolls Royce were unable to examine in detail or measure the sealant thickness on the loose blades; photographs of two of the loose blades (12 and 59) taken from the 7th stage compressor disc are given in Figures 3a and 3b. Prior to microscopic examination of the blades the surface distribution and thickness of the PL94/Molykote 106 layer was measured using a "mechanical" surface traversing procedure. Full details of the measurement method are given in Annex G. In summary it was found that a continuous layer of sealant varying in thickness from .01 mm to .05 mm (⁴/₁₀ of 1 thousandth of an inch to 2 thousandths of an inch) was present on both surfaces of the fir tree upper lands of blade No. 12. Due to the complexities of measuring the sealant thickness and distribution, and the need to examine the copper plating of at least one of the loose blades, only one blade was kept for sealant examination. For both blades the sealant was removed using citric acid. Considerable experimentation was required, using a variety of "solvents", before a method was developed to remove the baked PL94/Molykote 106 without affecting the copper plating. The stripping procedure used by Rolls Royce in Reference 2, sulphuric acid, would certainly have damaged the sub sealant copper plating. Subsequent micrographic examination of the copper plating of both blades 12 and 59 from the seventh stage did not reveal any defects in the copper plating, eg nodules, nor was there any evidence of incipient cracking in the copper plating or blade base material. The direct corollary of the finite and continuous layer of sealant is that a light gap, albeit very small, must have been present during the initial build of the compressor disc; the implications of a light gap on stresses in the blade root and fatigue life of the blade are addressed in Section 5.1 on Blade/Disc Design.

FIG 3A HEAVY LAYER OF SEALANT ON UPPER LANDS
OF LOOSE BLADE NO 12

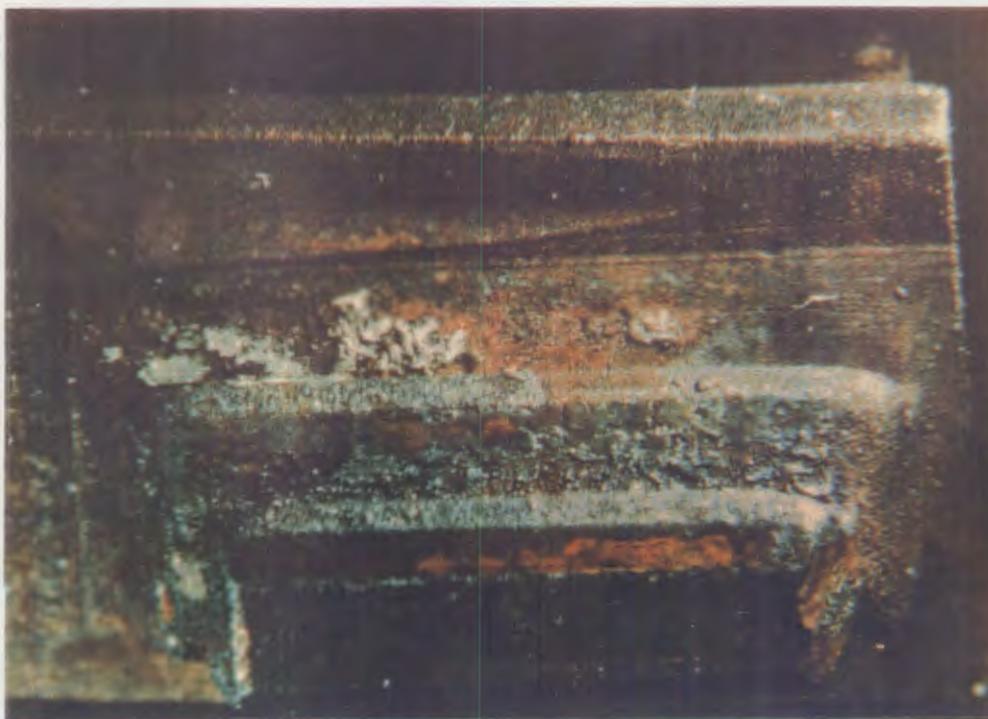
FIG 3B HEAVY LAYER OF SEALANT ON UPPER LANDS
OF LOOSE BLADE NO 59
COMMERCIAL-IN-CONFIDENCE

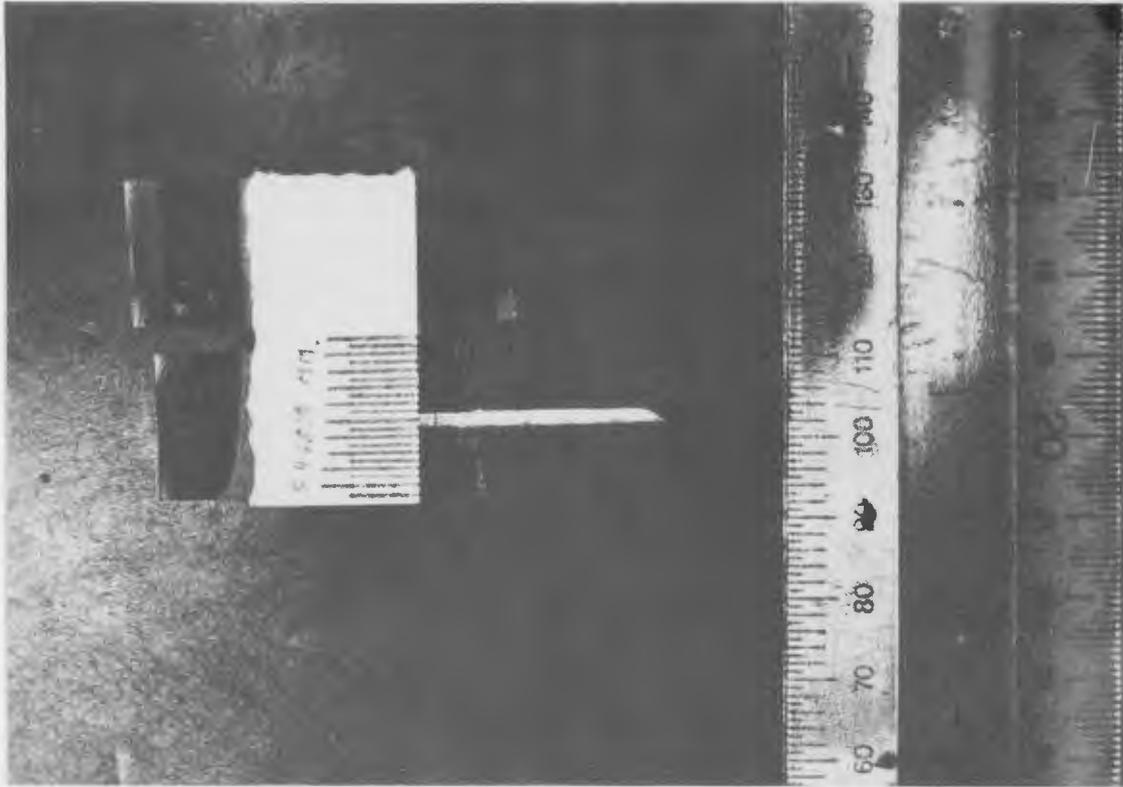
.0025 in. gap

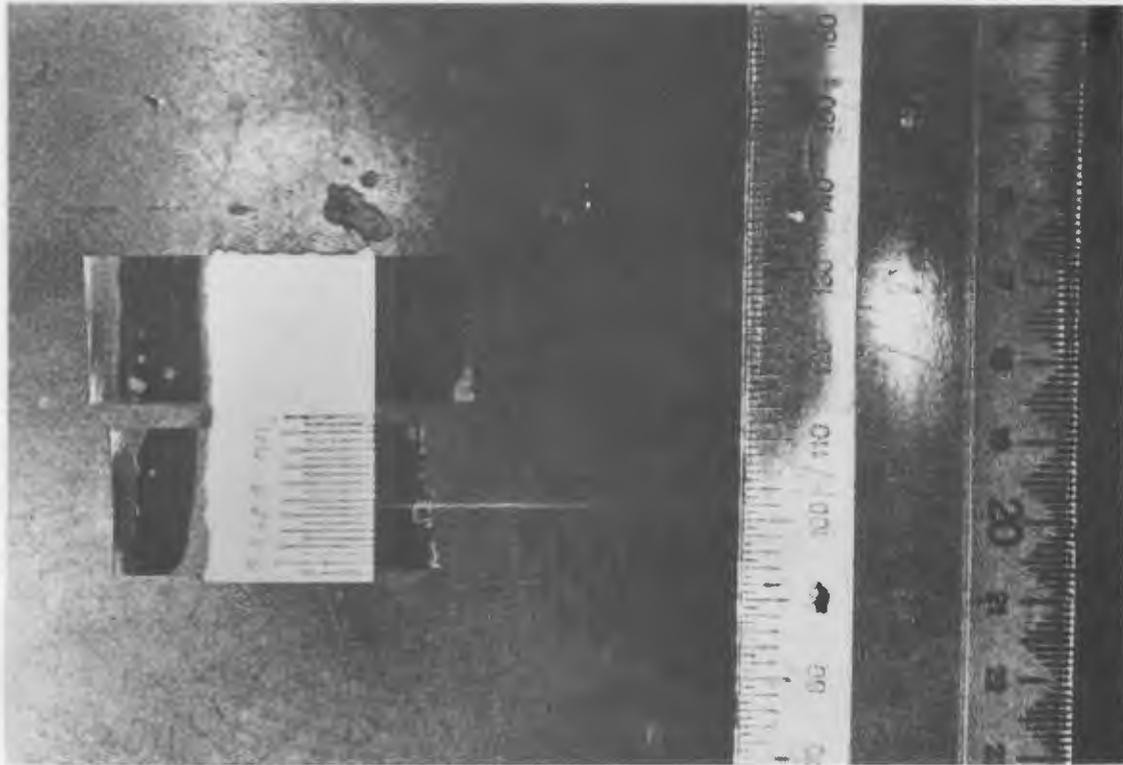
.0005 in. gap

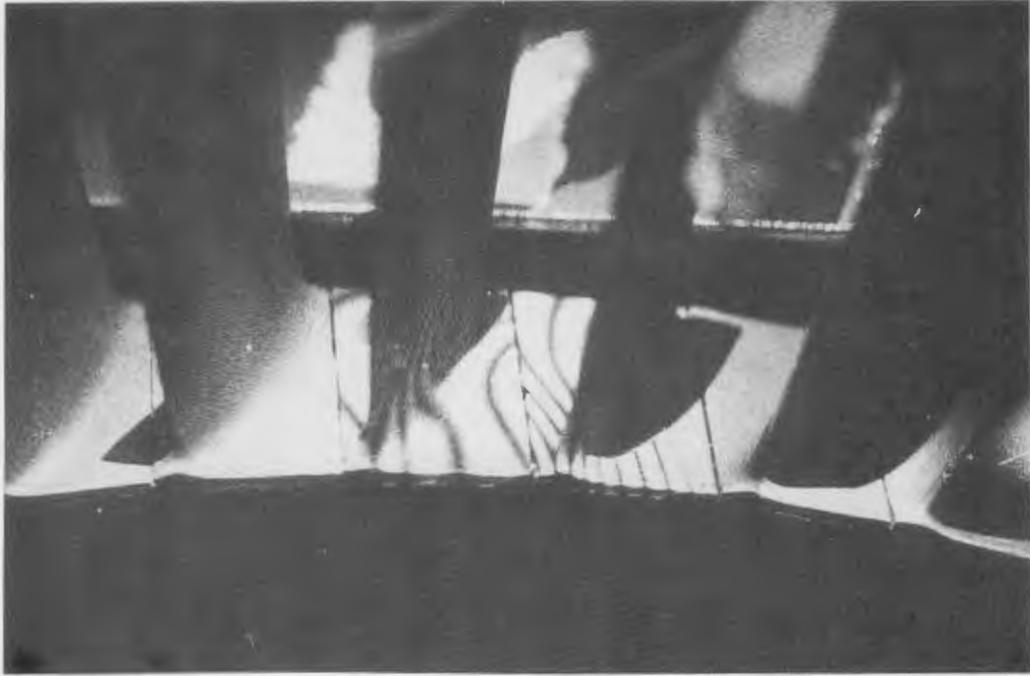
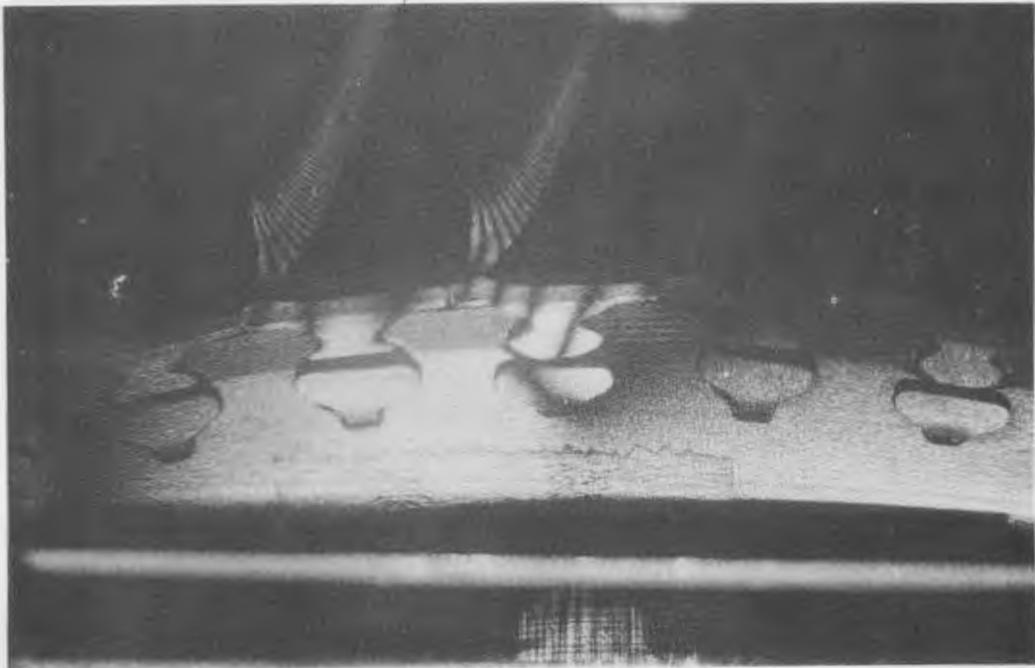
"No gap"

- Blade with gap at blade fir tree root upper land
- Platform movement indicated by number of fringes dark lines

FIG 7 INITIAL RESULTS OF LASER INTERFEROMETRIC HOLOGRAPHY ON BLADES ASSEMBLED INTO DISC WITH AND WITHOUT GAPS AT BLADE FIR TREE ROOT UPPER LAND
COMMERCIAL-IN-CONFIDENCE

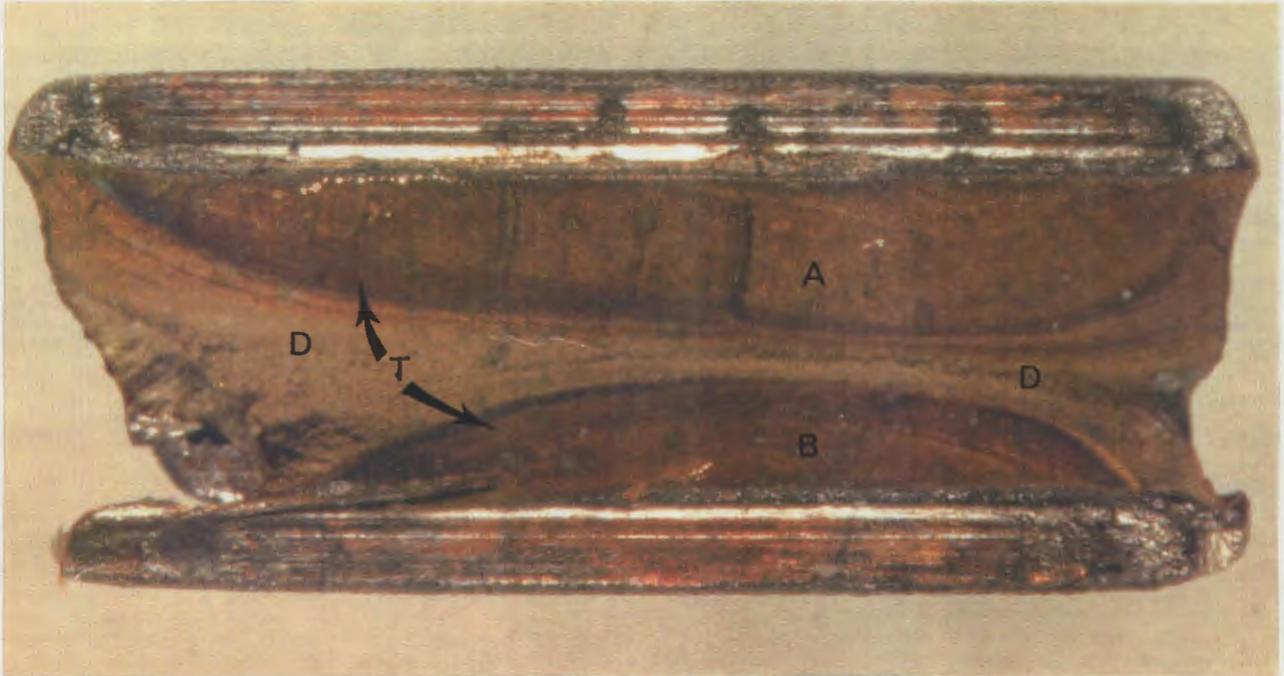
The only section of the failed blade which was available was that part directly held by the fir tree dovetail of the disc. Visual examination of the fracture surface indicated high cycle vibratory fatigue emanating from both leading and trailing surfaces of the blade root section. As the outer surface of the blade fir tree was extensively coated in cured PL94/Molykote 106, a dry lubricant with an epoxy base, it virtually precluded an examination of the outside surface for any signs of stress concentrators in the blade or its copper plating. A preliminary assessment of the failed blade by Aircraft Materials Division ARL is given in Reference 7 and Annex A. A comparison of the ARL and Rolls Royce findings indicates a dichotomy of views in that ARL state that the fatigue failure was initiated from a microscopic inclusion on the blade/copper plate surface and not from multiple origins located in a single axial stress raising feature (a score on the blade surface) as had been suggested by Rolls Royce. Subsequent sectioning of the failed blade root (Reference 14 and Annex H) confirmed the initial findings of the ARL - Aircraft Materials

FIG 1 THE FRACTURE SURFACE OF THE BROKEN 7TH STAGE COMPRESSOR BLADE FROM GAZELLE MK165C ENGINE SN GA2033. IN THIS PHOTOGRAPH THE LEADING SIDE OF THE BLADE IS AT THE TOP. TWO CRACKS ARE VISIBLE ON THE FRACTURE SURFACE. THE CRACK LABELLED A HAS INITIATED IN THE ROOT OF A FIR-TREE SERRATION ON THE LEADING SIDE OF THE BLADE, WHILE THE CRACK LABELLED B HAS ALSO INITIATED AT THE ROOT OF A FIR-TREE SERRATION, BUT ON THE TRAILING SIDE OF THE BLADE. A REGION OF HEAT-TINTED CRACKING IS VISIBLE ON BOTH CRACK FACES TOWARDS THE FINAL STAGES OF CRACK GROWTH (TYPICALLY AT ARROWS T; SEE ALSO FIG. 2). THE REGION OF THE FRACTURE SURFACE LABELLED D REPRESENTS THE MATERIAL OF THE BLADE EXPOSED WHEN THE COMPONENT FAILED IN OVERLOAD.

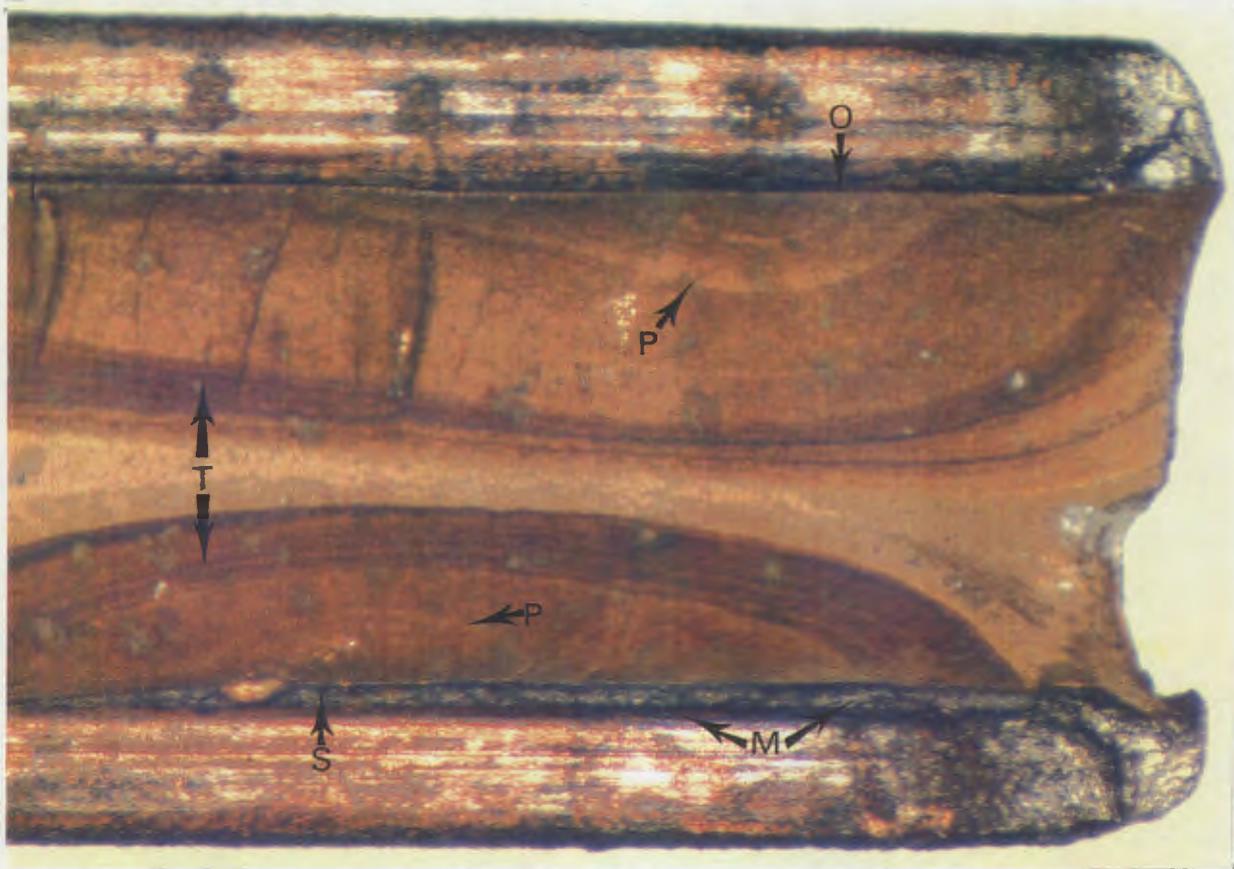
FIG 2 ENLARGED VIEW OF A PORTION OF THE TWO CRACKS ON THE FRACTURE SURFACE OF THE BLADE SHOWN IN FIG. 1. FATIGUE PROGRESSION MARKS ARE CLEARLY VISIBLE ON BOTH CRACK FACES (FOR EXAMPLE AT ARROWS P). THE BANDS OF HEAT-TINTED CRACK-GROWTH (NOTED IN FIG. 1) ARE REVEALED, AT THIS MAGNIFICATION, TO BE A SERIES OF DARK AND LIGHT ZONES (ARROWS T). THE INITIATION SITE OF THE CRACK ON THE LEADING SIDE OF THE BLADE IS INDICATED BY ARROW O, WHILE THE INITIATION SITE FOR THE CRACK ON THE TRAILING SIDE IS ARROWED S. MOLYBDENUM DISULPHIDE CAN BE SEEN IN THE AREAS INDICATED BY ARROWS M.

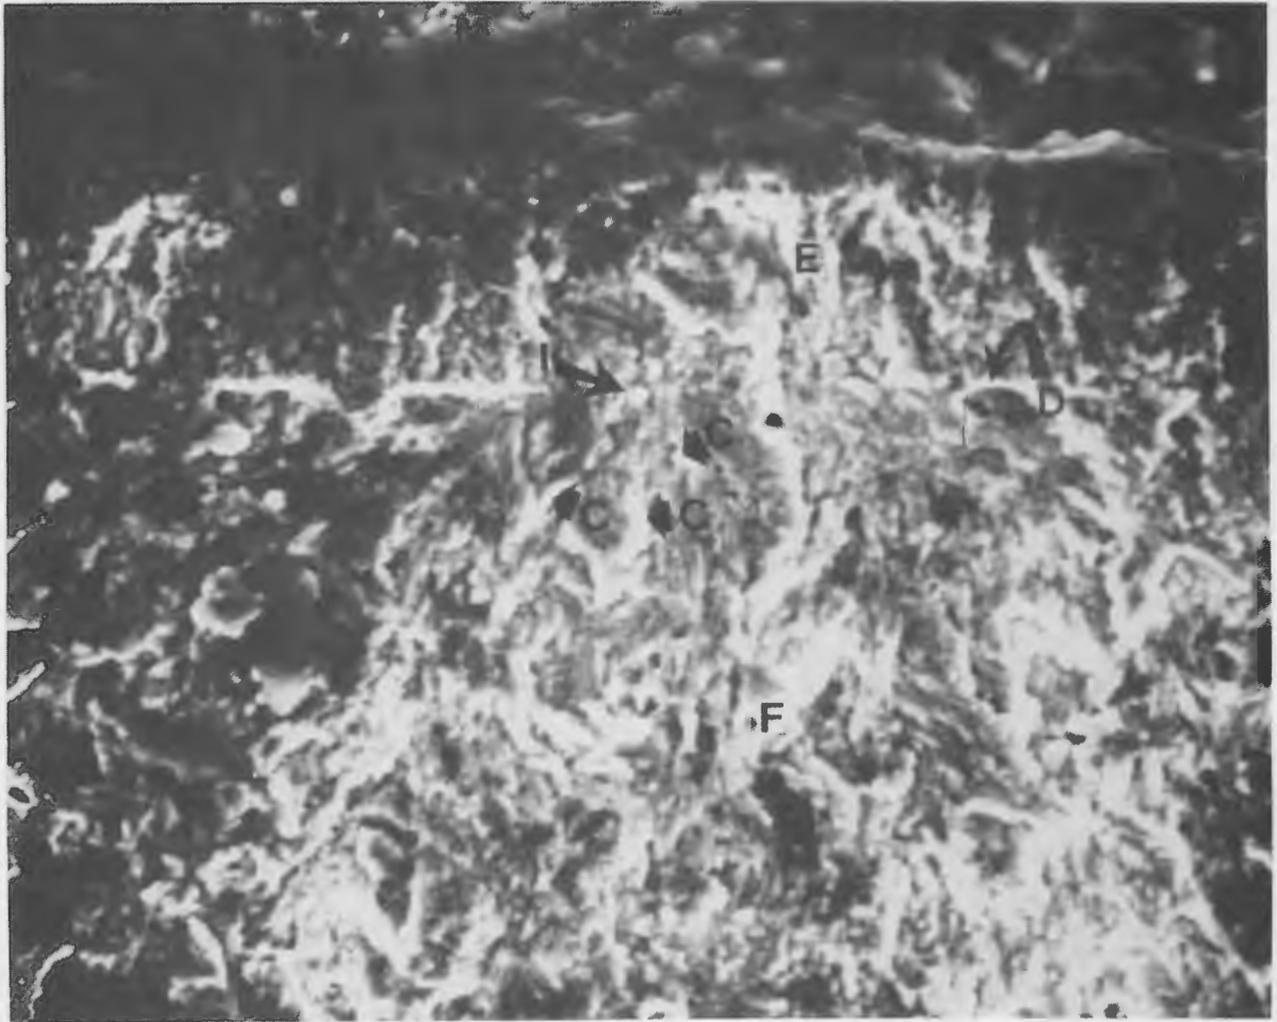
a. The blade failure was initiated at a small inclusion in the 7PJ material. Sectioning in the vicinity of the inclusion was unable to locate or identify any defect in the copper plating which could have initiated a fatigue crack as had been surmised by Rolls Royce in Reference 2.

FIG 3 HIGH MAGNIFICATION SCANNING ELECTRON MICROSCOPE PHOTOGRAPH OF THE ORIGIN (ARROWED O, FIG.2) OF THE CRACK ON THE LEADING SIDE OF THE BLADE. THE FRACTURE SURFACE OF THE CRACK IN THE BLADE MATERIAL IS LABELLED F. THE FRACTURE SURFACE OF THE COPPER PLATE IS LABELLED E, WHILE THE BOUNDARY BETWEEN THE COPPER PLATE AND THE BLADE MATERIAL IS ARROWED D. AT THE TOP OF THIS PHOTOGRAPH, LABELLED M, IS THE MOLYBDENUM DISULPHIDE COATING ON THE (NORMALLY) EXTERNAL SURFACE OF THE BLADE (IN THIS CASE THE ROOT OF THE FIR-TREE SERRATION). THE "RIVER" PATTERN OR CHEVRON MARKINGS (AT ARROWS C) ON THE BLADE FRACTURE SURFACE POINT TO AN INCLUSION, ARROWED I, AS THE ORIGIN OF THE CRACK ON THE LEADING SIDE OF THE BLADE. THE INCLUSION IS APPROXIMATELY 1.6 MICRONS IN DIAMETER.

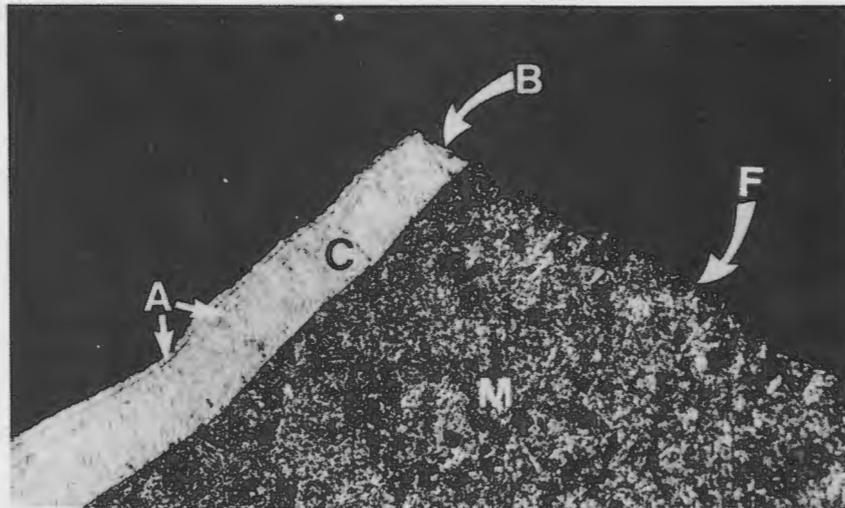
FIG 1. POLISHED AND ETCHED METALLOGRAPHIC SECTION FROM THE FAILED BLADE FROM ENGINE SN GA2033. THE AREA SHOWN IN THIS PHOTOGRAPH IS IMMEDIATELY ADJACENT TO THE PRIMARY CRACK INITIATION SITE (ESTIMATED TO BE WITHIN 0.2 mm). THE PRIMARY CRACK FRACTURE SURFACE IS ARROWED F; THE BLADE MATERIAL IS LABELLED M; THE COPPER PLATE IS LABELLED C; AND THE FRACTURE SURFACE OF THE COPPER PLATE IS ARROWED B. NOTE THAT THE ETCHANT HAS REVEALED THE BOUNDARIES (ARROWS A) BETWEEN THE DIFFERENT LAYERS OF COPPER PLATE (THREE IN ALL). SIGNIFICANTLY THESE BOUNDARIES FINISH ABRUPTLY AT THE BREAK IN THE PLATING (ARROW B). THE THICKNESS OF THE COPPER PLATE IS ABOUT 0.05MM AT THE BREAK.

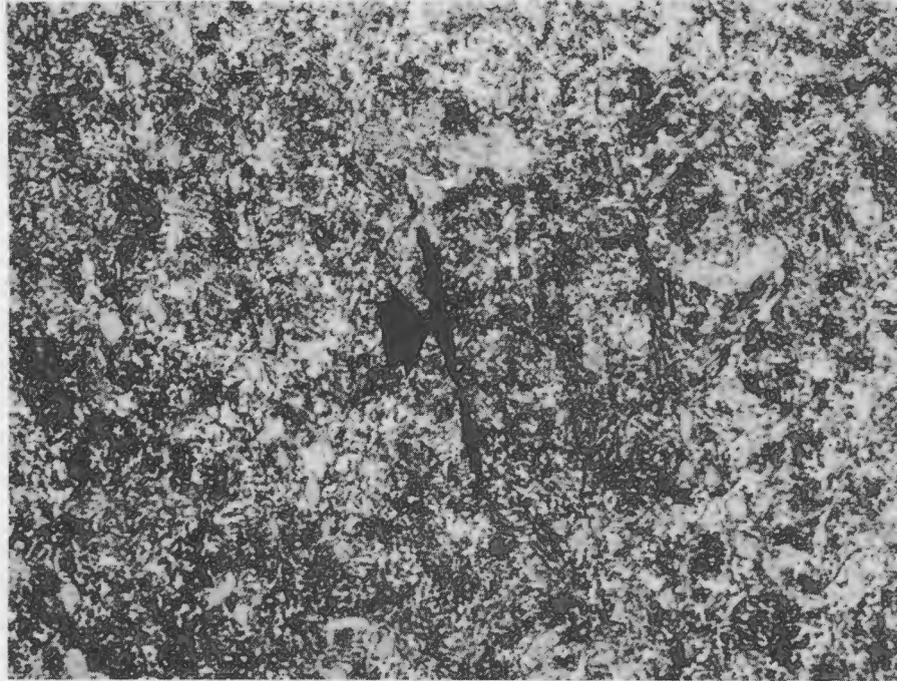
c. A comparison of metallographic sections taken from samples of 7PJ blades and from blades from batch 7AZ shows that there is a significant difference in inclusion size and number between the failed blade batch 7PJ and that of the 7AZ. The 7PJ batch contained a greater number of large inclusions (up to 30 micron) and has a greater number of inclusions overall; the observed increase in size and nature of inclusions would increase the probability of an inclusion initiating a blade failure.

FIG 2. A STRINGER TYPE INCLUSION (ARROWED) OF THE TYPE FOUND IN THE FAILED BLADE AND IN OTHER 7PJ BLADES. THIS TYPE OF INCLUSION WAS NOT FOUND IN BLADES FROM OTHER BATCHES EXAMINED. THE LENGTH OF THIS INCLUSION IS ABOUT 30 MICRONS.

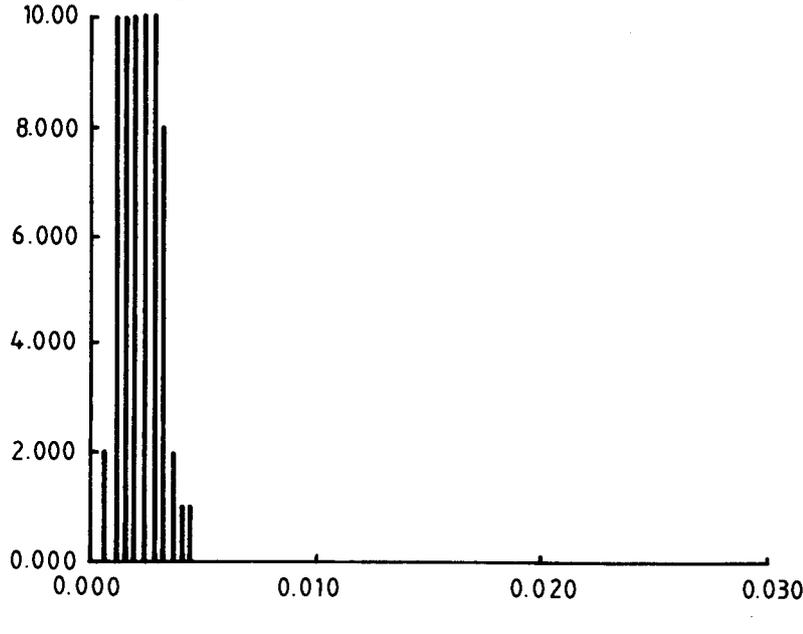
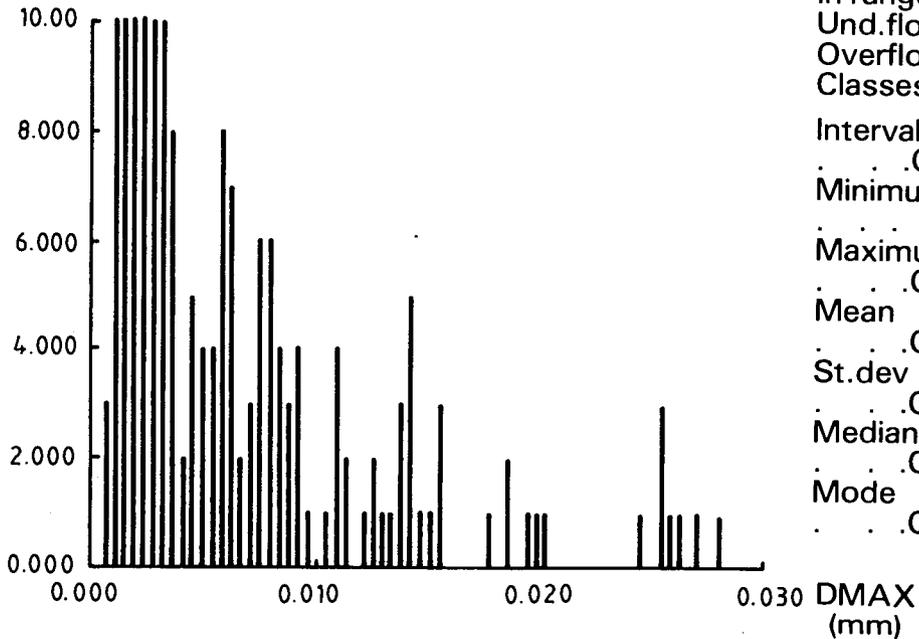
FIG 3 GRAPHICAL REPRESENTATION OF THE INCLUSION SIZE AND DISTRIBUTION ANALYSIS OF THE FAILED BLADE (BOTTOM GRAPH) AND A BLADE FROM BATCH 7AZ. 'DMAX' IS THE MAXIMUM PARTICLE DIMENSION (I.E. IN THE CASE OF THE INCLUSION SHOWN IN FIGURE 2, DMAX WOULD BE THE LENGTH OF THE INCLUSION. 'ABS FREQUENCY' IS THE NUMBER OF TIMES THE PARTICULAR DMAX WAS DETECTED. NOTE THAT THE FAILED BLADE HAS A HIGHER OVERALL PROPORTION OF INCLUSIONS AND, IN PARTICULAR, A GREATER NUMBER OF INCLUSIONS WITH A DMAX OF GREATER THAN ABOUT 5 MICRONS. SEE PARAGRAPHS 5 & 6 OF THE TEXT FOR A MORE DETAILED DISCUSSION.

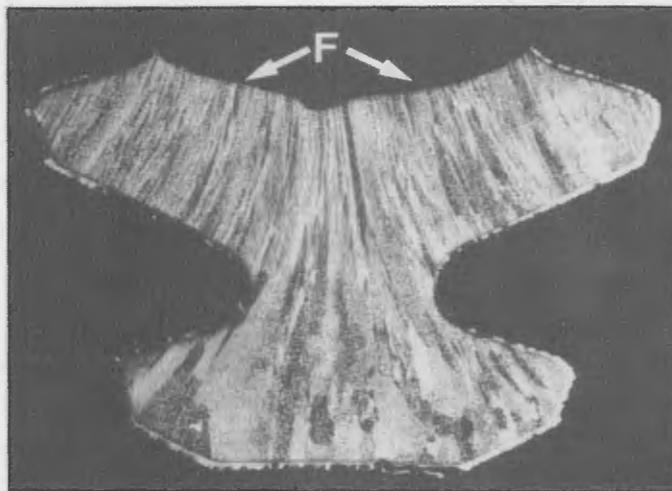
b. The etched macro structure of the failed blade was markedly different to that of other blades including other 7PJ batches, in that there was evidence of a distinctly banded non-homogeneous structure. The complex banded structure or striations of the failed blade, described in detail in Annex H, is an atypical microstructure which may have resulted from anomalous heat treatment. Details of material specifications, manufacture, forging, heat treatment and inspection procedures are given in References 16 and 19. Whilst the materials specification details inspection procedures and sample sizes (typically two blades/500 forgings or "set" - not necessarily a complete material batch) it does not detail consequential/rejection procedures to be used if any of the two blades fail to meet the specifications. In this investigation it must be assumed that the two sample blades taken from the "set" from which the failed blade emanated did not fail the inspection criteria. Notwithstanding this the possibility must exist that other PJ blades from that set could display the same features. As total batch sizes of PJ, AZ etc material are not known it should not be concluded that the whole PJ batch (consisting of possibly many 500 blade sets) is suspect. (It is known, Reference 19, that 3633 blades carrying 7PJ identifier were produced, whilst an unknown number of other compressor blades for other stages was manufactured from the remaining part of the PJ batch). However until more precise data are available from Rolls Royce, the SAMR decision to remove all 7PJ blades from Gazelle compressors currently being built is endorsed. It is believed that the resulting metallurgical structure, of the failed blade, would lead to an increased variability of the material mechanical properties and in particular fatigue strength of the blade, and could be conducive to accelerated failure.

FIG 4. PHOTOGRAPH OF THE ETCHED MACROSTRUCTURE OF THE FIR-TREE OF THE FAILED BLADE. THE FRACTURE SURFACE IS ARROWED F. NOTE THE DISTINCTLY BANDED STRUCTURE, AND COMPARE THIS WITH FIGURE 5.

From data presented on batch 7PJ and detailed in ANNEX H it is recommended that Rolls Royce carry out a metallurgical examination, including etching of other Gazelle failed blades and in particular those of batch 7PJ.

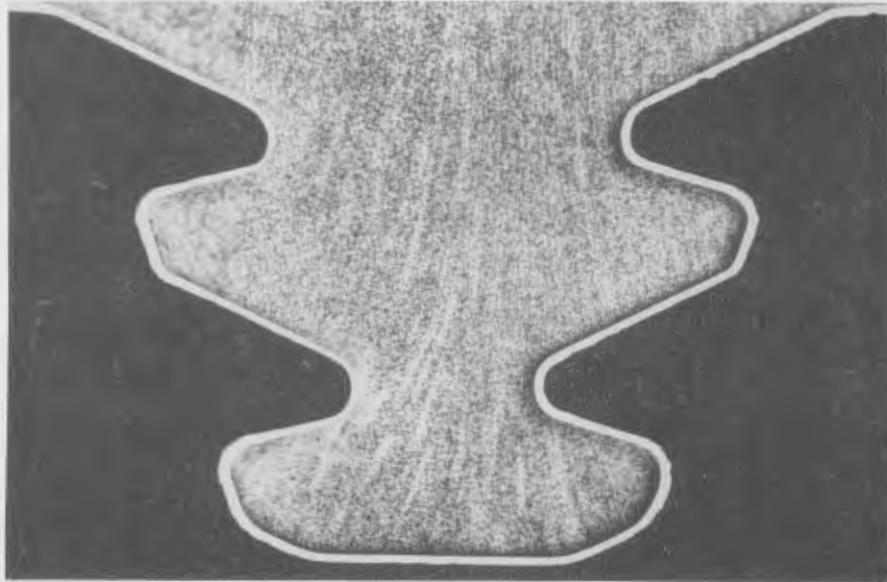
FIG 5. MACROSTRUCTURE OF A BLADE FROM BATCH 7AZ. THIS STRUCTURE IS TYPICAL FOR ALL BLADES EXAMINED WITH THE ONLY EXCEPTION BEING THE FAILED BLADE (SEE FIGURE 4).

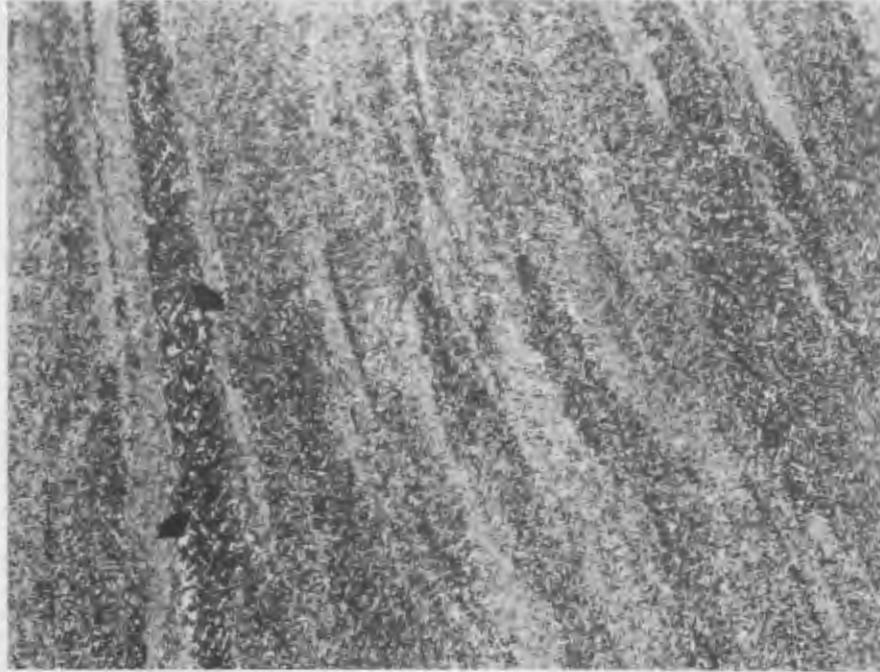
FIG 6. MICROSTRUCTURE OF THE FAILED BLADE. A HIGHLY BANDED STRUCTURE IS EVIDENT. THE LIGHT GREY, MOTTLED PHASE, WHICH IS IN THE MAJORITY, IS PREDOMINANTLY AN ALPHA MATRIX CONTAINING KAPPA PRECIPITATE. THE DARKER BANDS CONTAIN BOTH DARK AND LIGHT ETCHING PHASES (ARROWED – SEE ALSO FIGURES 7 & 8).

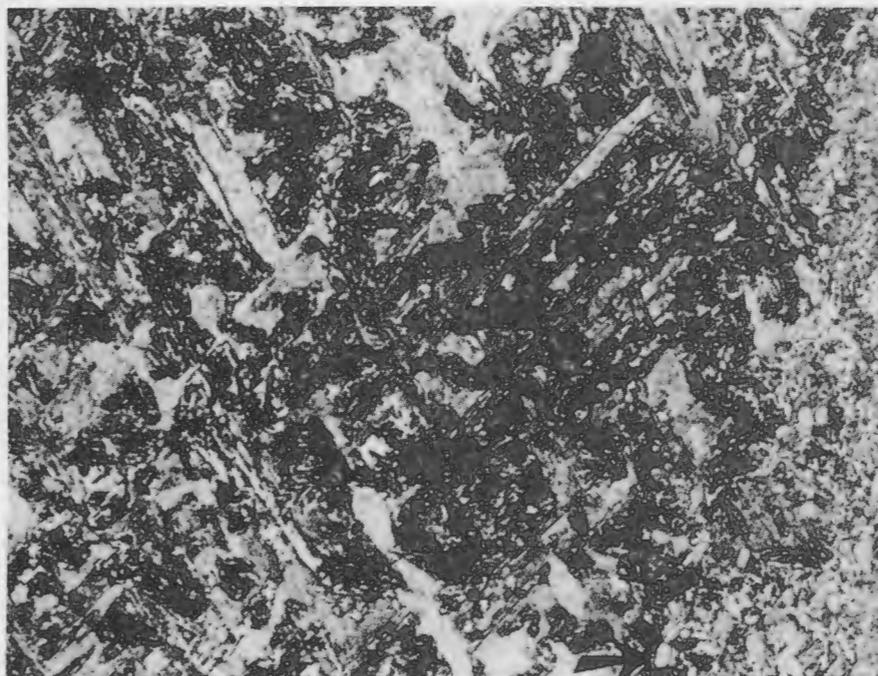
FIG 8. AT THE MAXIMUM MAGNIFICATION AVAILABLE ON THE OPTICAL MICROSCOPE THE STRUCTURE OF THE DARK STRIPES SEEN IN FIGURES 6 & 7 WAS FOUND TO CONSIST OF A MIXTURE OF ALPHA (LIGHT GREY) AND WHAT APPEARS TO BE PARTIALLY DECOMPOSED BETA (DARK GREY TO BLACK – SEE TEXT). NOTE THE SIZE OF THE ROUNDED PARTICLES OF KAPPA (ARROWED) AND COMPARE WITH FIGURE 9.

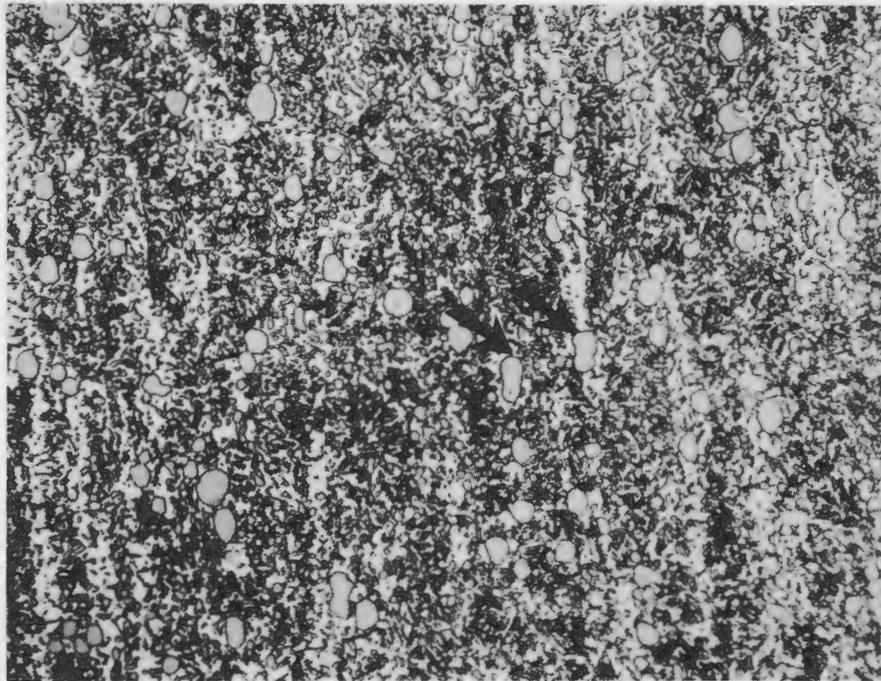
FIG 9. PHOTOGRAPH OF THE MICROSTRUCTURE OF THE BLADE FROM BATCH 7AZ SHOWN IN FIGURE 5. THE STRUCTURE CONSISTS ENTIRELY OF AN ALPHA MATRIX CONTAINING ROUNDED PARTICLES AND LAMELLAE OF KAPPA. NO EVIDENCE OF INCLUSIONS OF THE TYPE SHOWN IN FIGURE 2 WERE FOUND IN THIS BLADE OR ANY OTHER BLADES EXAMINED FROM BATCHES OTHER THAN 7PJ. NOTE THE SIZE OF THE ROUNDED KAPPA PARTICLES (ARROWED) IN COMPARISON TO THAT OF THE FAILED BLADE. (FIGURE 8) – ALSO NOTE, HOWEVER, THAT THE MAGNIFICATIONS ARE DIFFERENT.

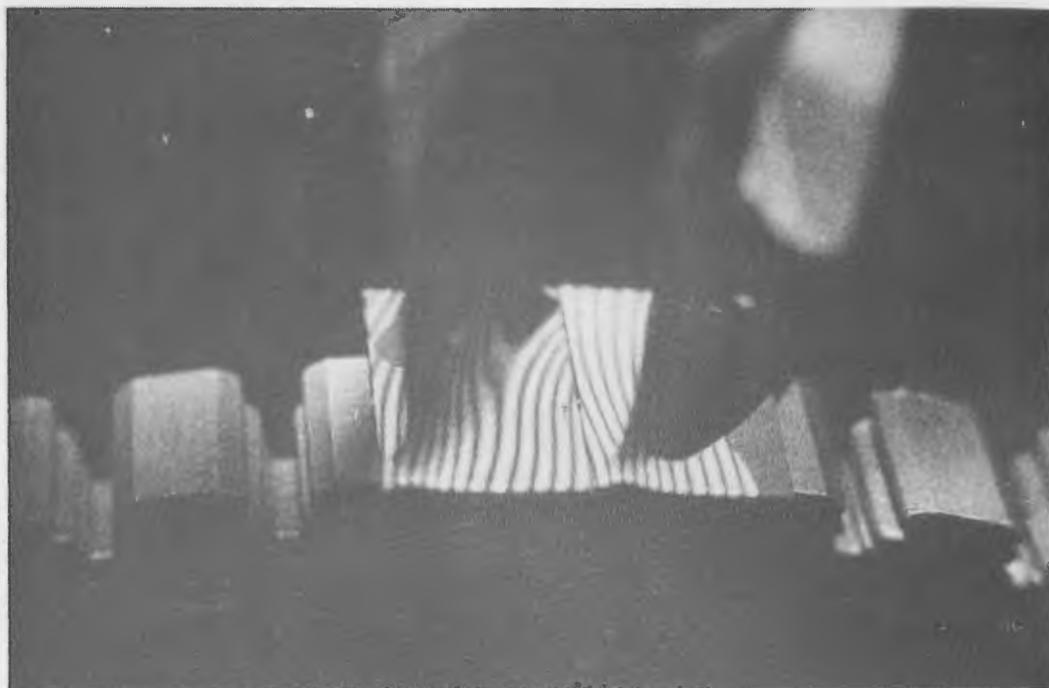
FIG. 5 END-ON VIEW ILL-FITTING BLADE

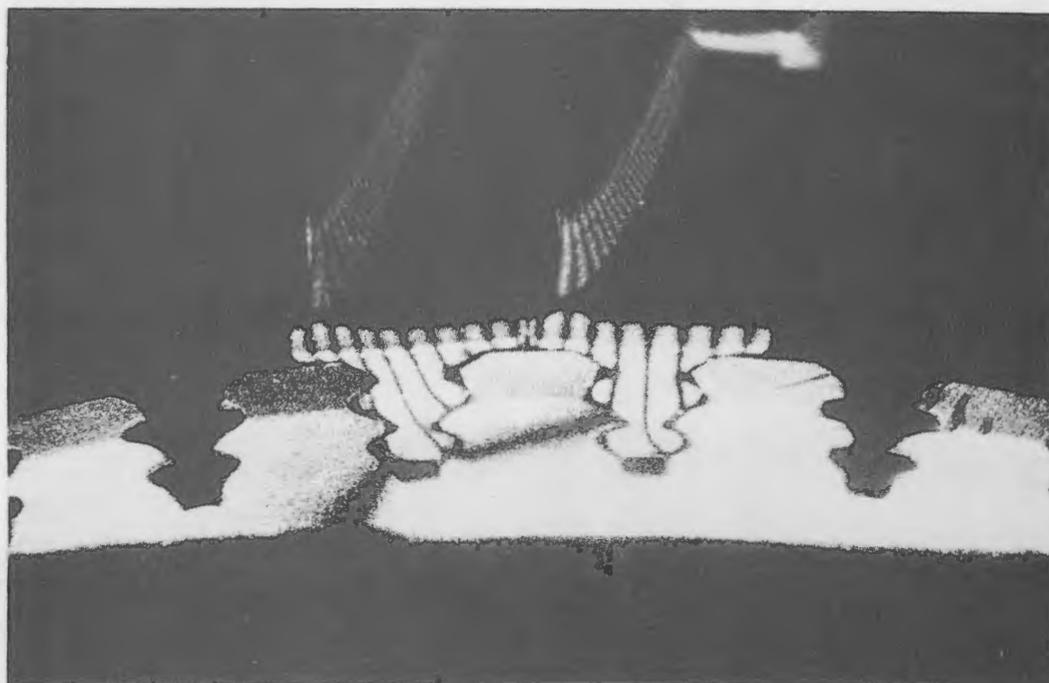
FIG. 6 SIDE-ON VIEW ILL-FITTING BLADE
COMMERCIAL-IN-CONFIDENCE
