MINUTE PAPER

GANNET AIRCRAFT S/N^o XA 332

BOARD OF ENQUIRY

DEPT. OF NAVY
3054/118/62.

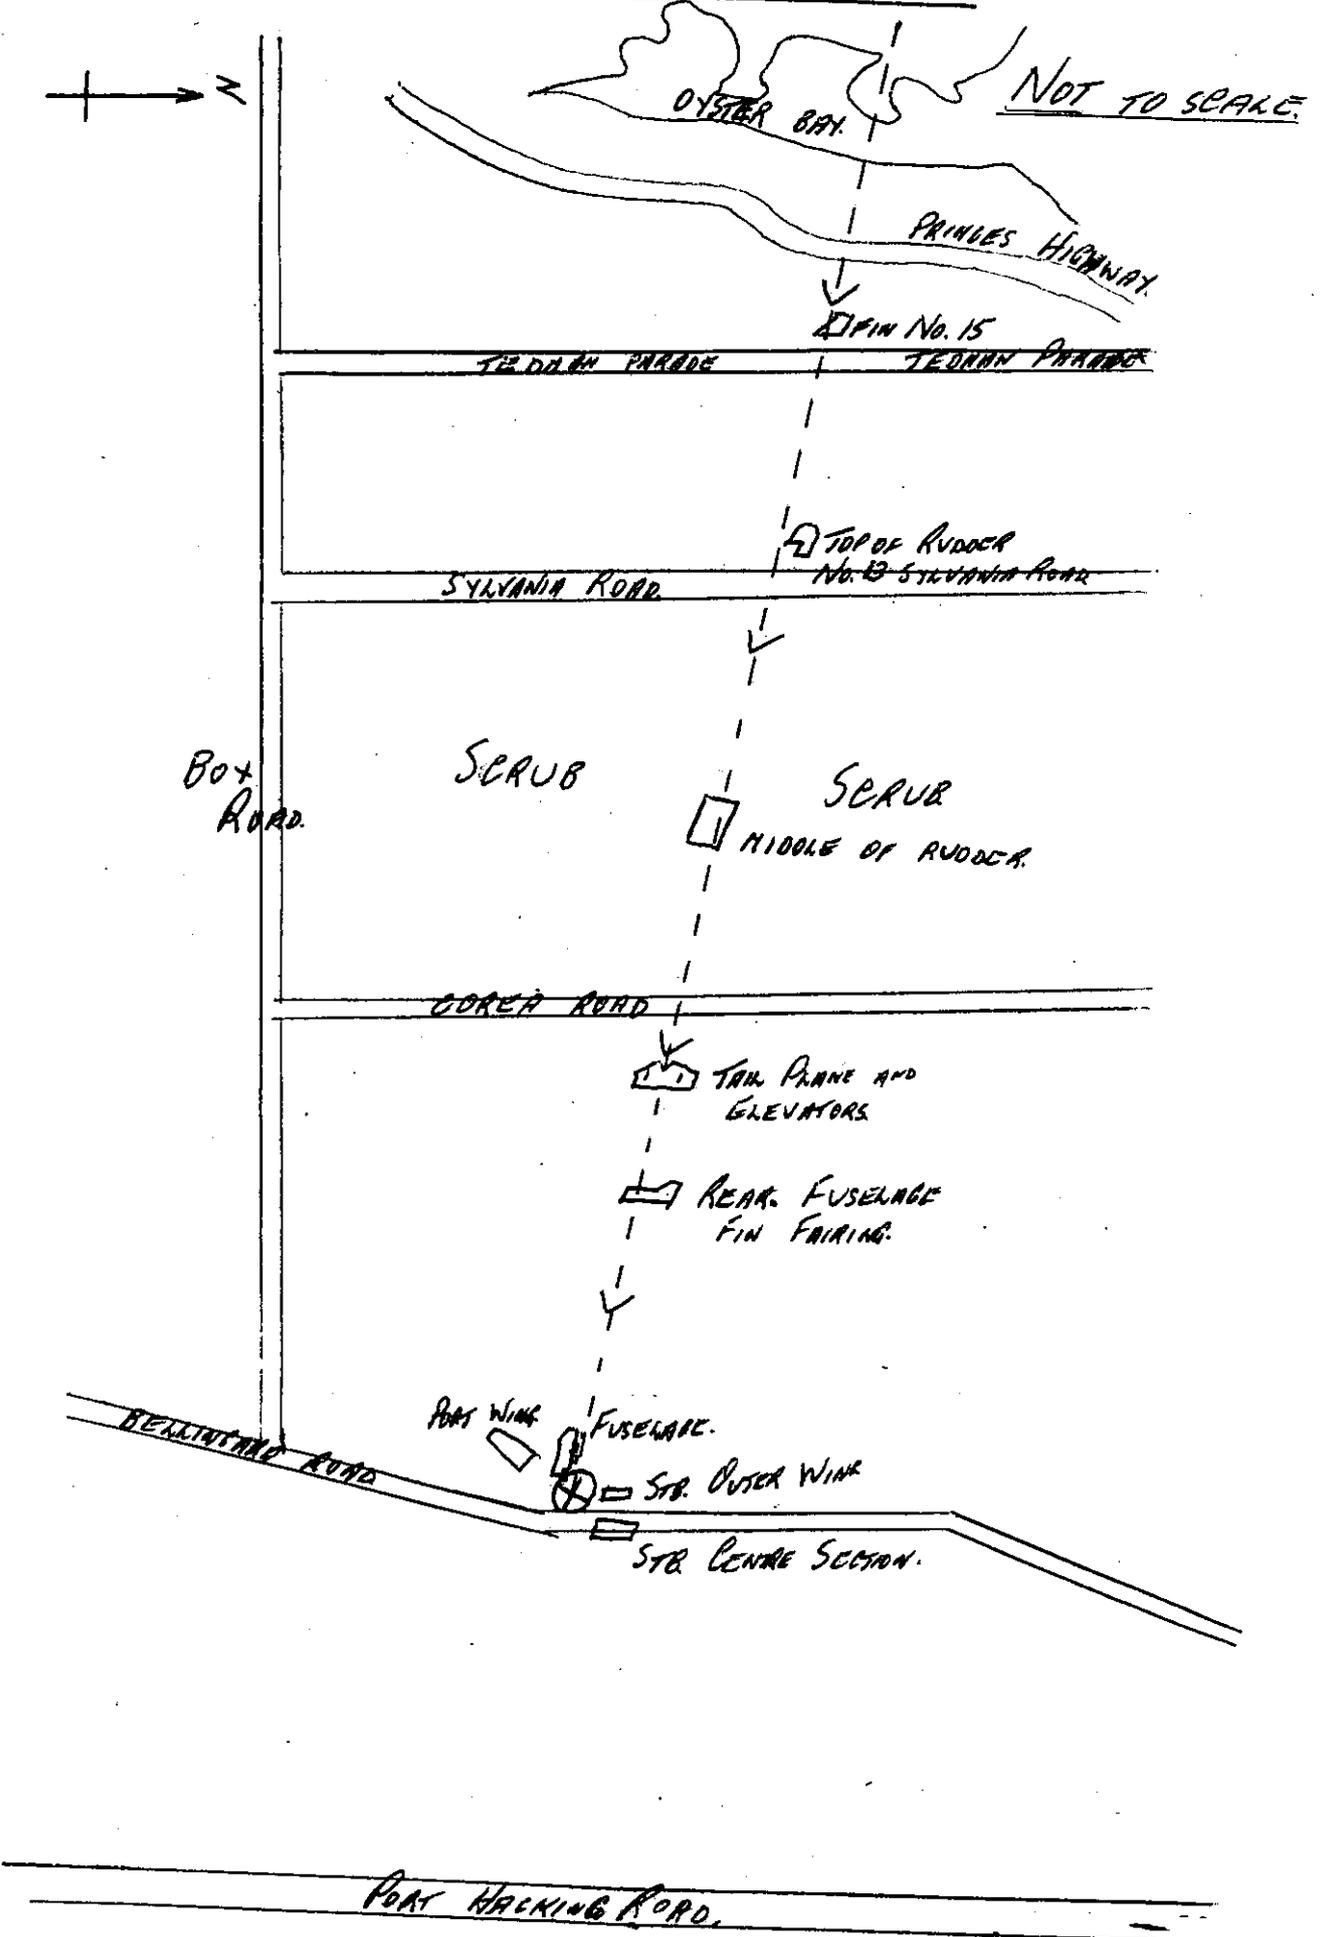
DIAGRAM OF TAIL UNIT PIECES.

as before. Shortly after this when nearing Prince's Highway, the tail unit of the aircraft commenced to break up. A total of 5 pieces were observed to fall from the aircraft in what appeared to be the following order:-
