NZ Aerospace CT-4 Airtrainer A19-028 crashed at Oakey, Queensland on 16 August 1979 killing the crew of two. From an inspection of the ground impact markings, it was determined that the aircraft had been diving at 25° with 10° of starboard bank when initial ground impact occurred. Following this impact, the aircraft bounced and finally came to rest during a second heavy impact. A thorough examination of the wreckage disclosed no evidence of any pre-crash defect, all control surfaces and control runs were intact at ground impact, and it was concluded that the aircraft flew into the ground because of the pilot's inattention to his flight path. Despite the fact that the cockpit structure survived relatively intact, Fig. 58, this accident was considered non-survivable because of the large vertical accelerations experienced.

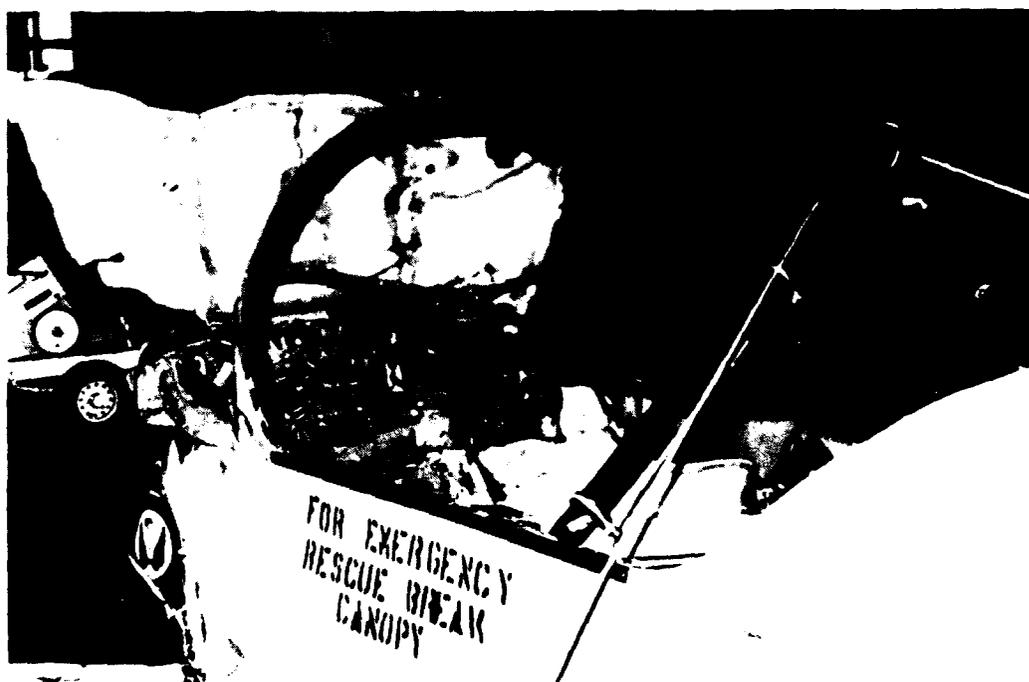
Fig. 58 Cockpit structure of A19-028 after the accident. Note the impact damage to the instrument panel and the missing windscreen

However, both occupants received fatal injuries when they were thrown through the windscreen. This should not have happened. A close examination of their safety harnesses revealed that these had been fitted properly, inertia reels had locked correctly, and the harnesses had not failed through overload. Instead, the quick release buckles had distorted during the initial impact and then unlocked during the subsequent rebound allowing the occupants to be ejected during the second heavy impact. This accident accelerated ARL research into pilot restraint systems with particular attention being given to improved designs of quick release buckles.
