**DEPARTMENT OF DEFENCE
DEFENCE SCIENCE AND TECHNOLOGY ORGANISATION
AERONAUTICAL RESEARCH LABORATORY**

General Document 37

**AIRCRAFT ACCIDENT INVESTIGATION AT ARL
THE FIRST 50 YEARS**

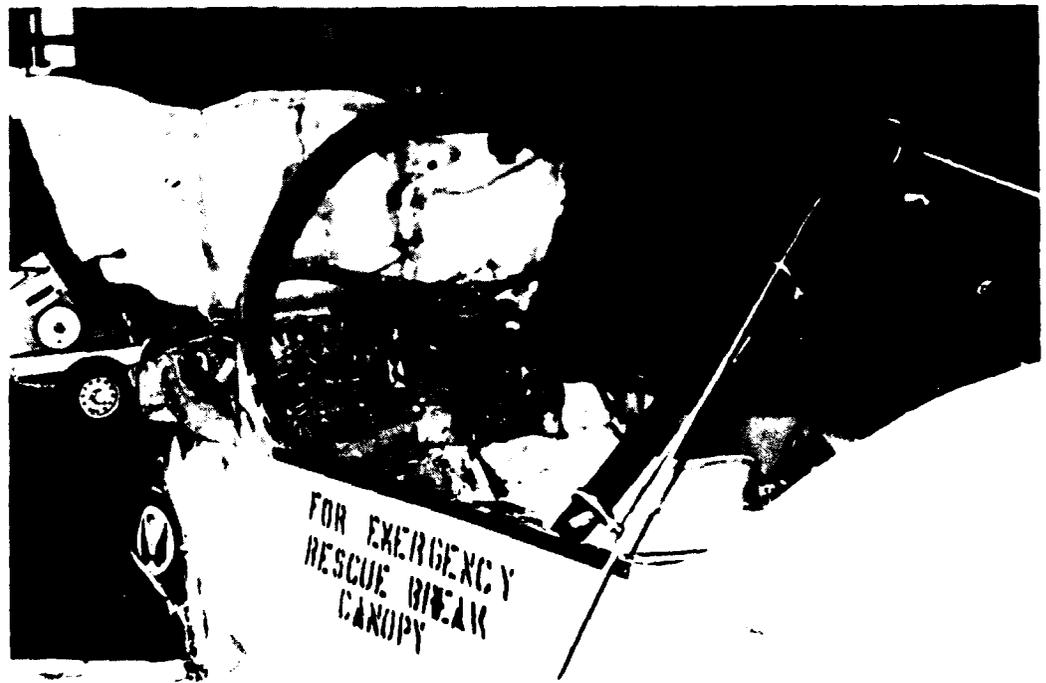
NZ Aerospace CT-4 Airtrainer A19-028 crashed at Oakey, Queensland on 16 August 1979 killing the crew of two. From an inspection of the ground impact markings, it was determined that the aircraft had been diving at 25° with 10° of starboard bank when initial ground impact occurred. Following this impact, the aircraft bounced and finally came to rest during a second heavy impact. A thorough examination of the wreckage disclosed no evidence of any pre-crash defect, all control surfaces and control runs were intact at ground impact, and it was concluded that the aircraft flew into the ground because of the pilot's inattention to his flight path. Despite the fact that the cockpit structure survived relatively intact, Fig. 58, this accident was considered non-survivable because of the large vertical accelerations experienced.

Fig. 58 Cockpit structure of A19-028 after the accident. Note the impact damage to the instrument panel and the missing windscreen

However, both occupants received fatal injuries when they were thrown through the windscreen. This should not have happened. A close examination of their safety harnesses revealed that these had been fitted properly, inertia reels had locked correctly, and the harnesses had not failed through overload. Instead, the quick release buckles had distorted during the initial impact and then unlocked during the subsequent rebound allowing the occupants to be ejected during the second heavy impact. This accident accelerated ARL research into pilot restraint systems with particular attention being given to improved designs of quick release buckles.
