DIRECTORATE OF DEFENCE AVIATION AND AIR FORCE SAFETY

AIRCRAFT ACCIDENT INVESTIGATION REPORT

**LOSS OF BLACK HAWK A25-221
EMBARKED IN HMAS KANIMBLA, NEAR FIJI
29 NOV 06**

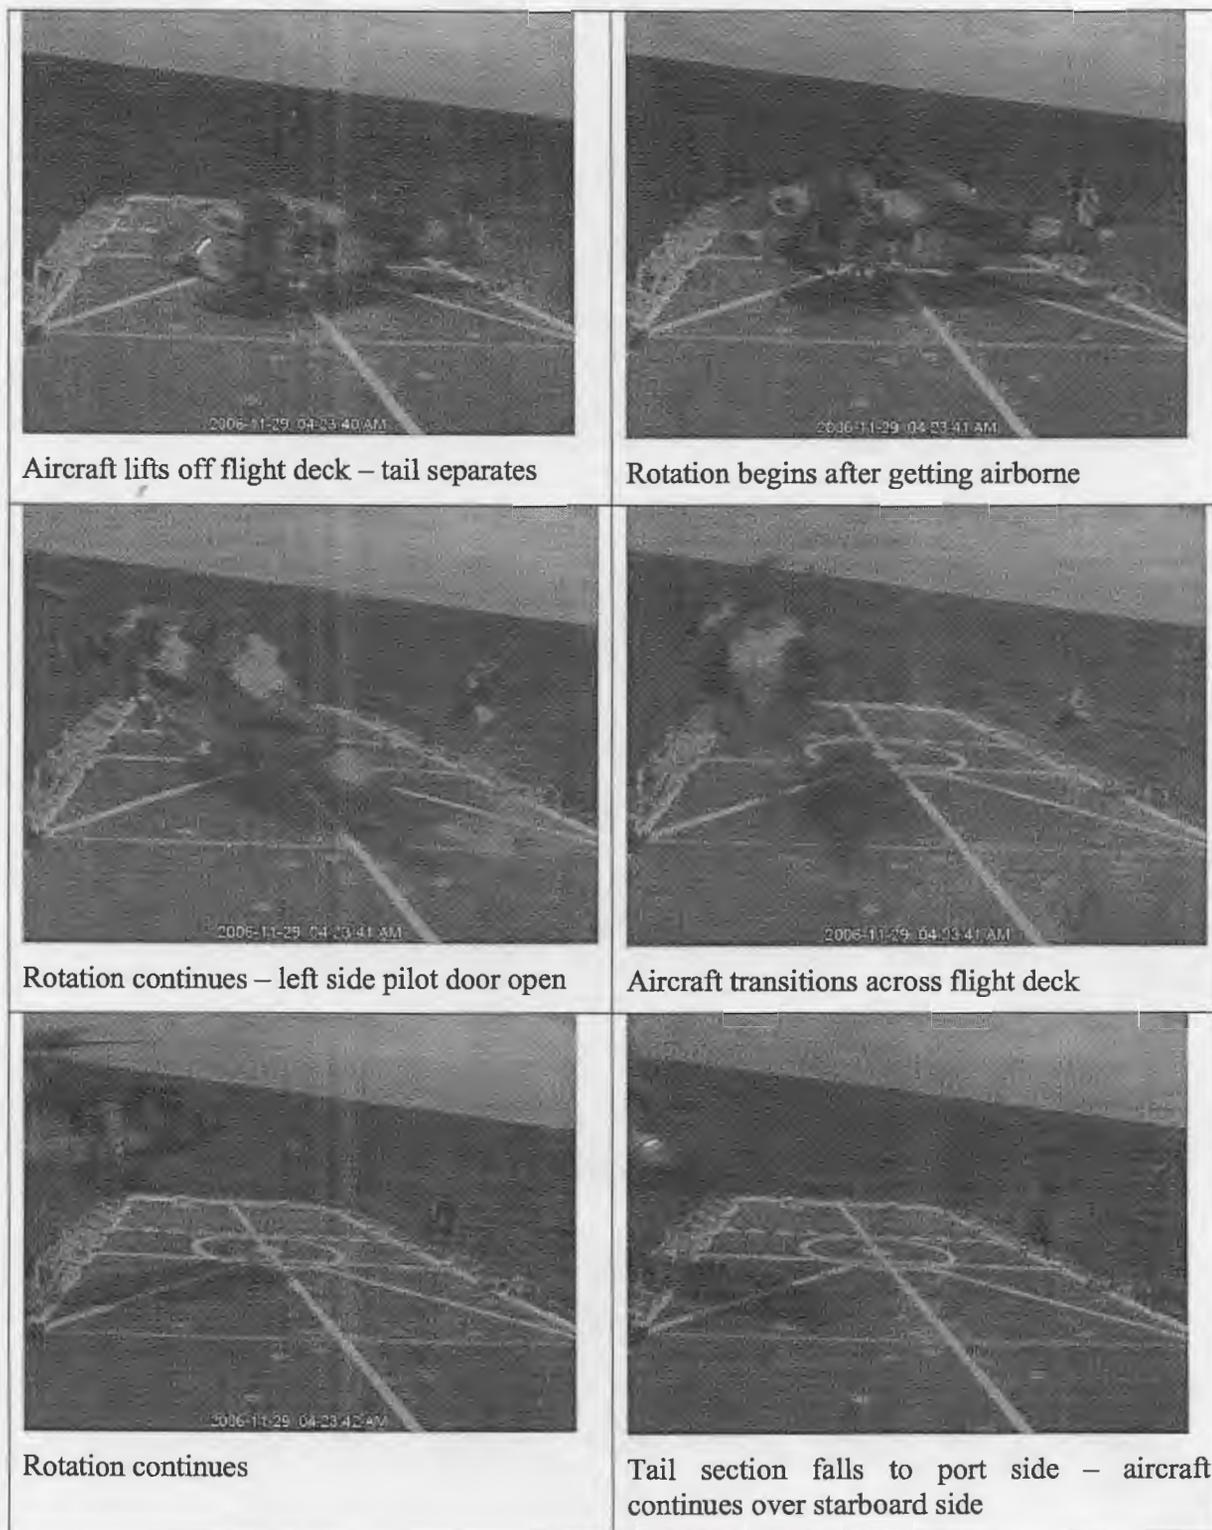
Figure 5. Captured images of accident sequence

18. During the accident sequence, the fuselage impacted the flight deck, whilst the tail boom and rotor separated from the aircraft after colliding with the edge of the flight deck, falling over the port side of the ship. The remaining fuselage section became airborne, rotating and transitioning laterally across the flight deck, eventually falling into the ocean on the starboard side of the ship.

19. The following images depict the aircraft post accident on deck and subsequent manoeuvre across the deck.

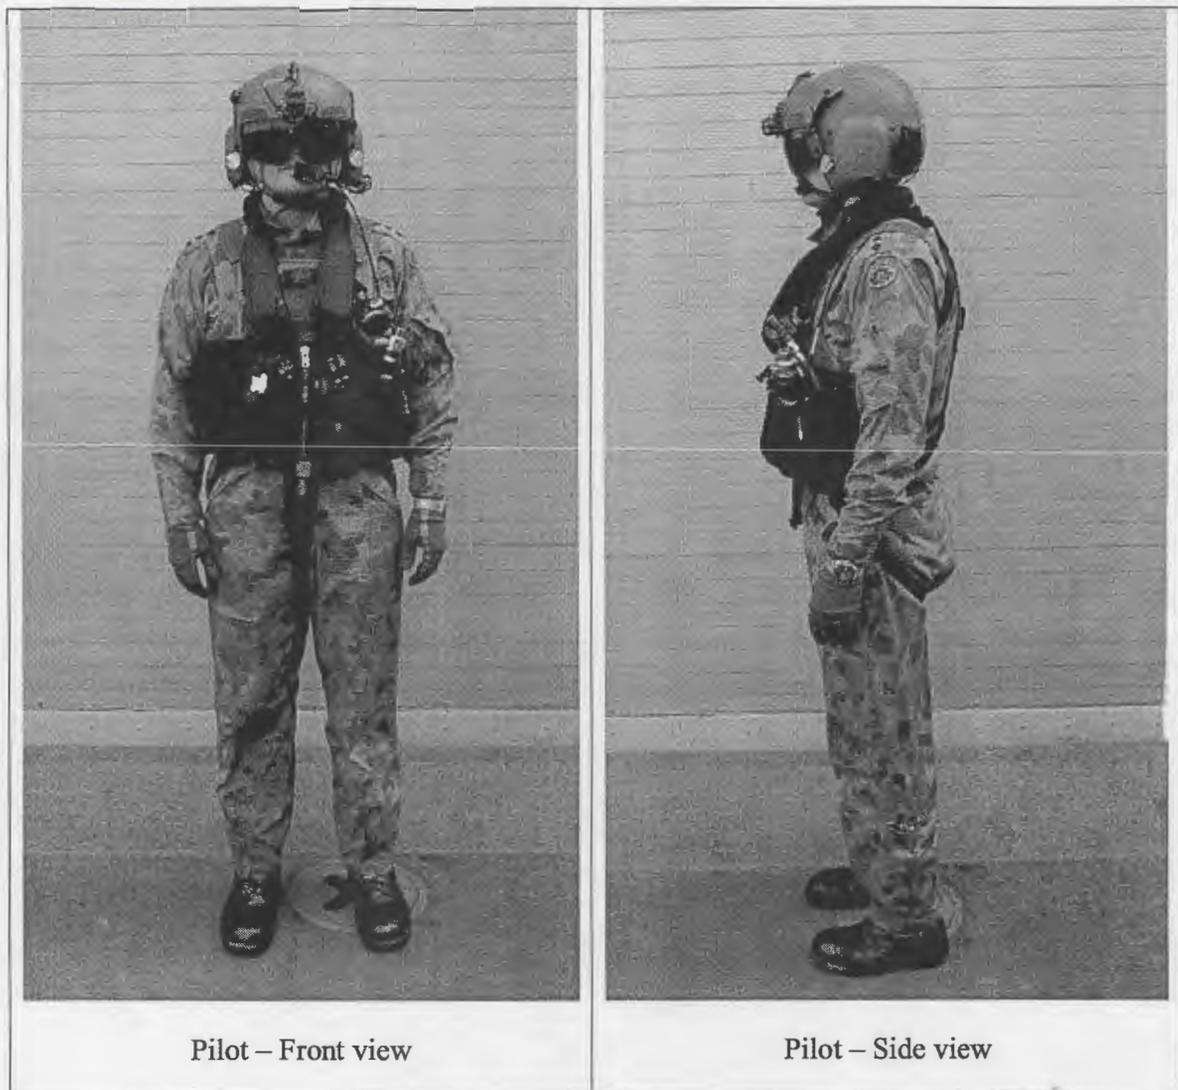
Figure 7. Pilot LSE

- a. **Pilot.** HGU-56P aircrew helmet damaged, Simula Low Profile Survival Vest (LPSV) with LPU-34/P flotation collar incomplete with missing right pocket and both bladders activated, no HABD bottle or regulator, ballistic vest rear panel only. Full set of flying clothing.

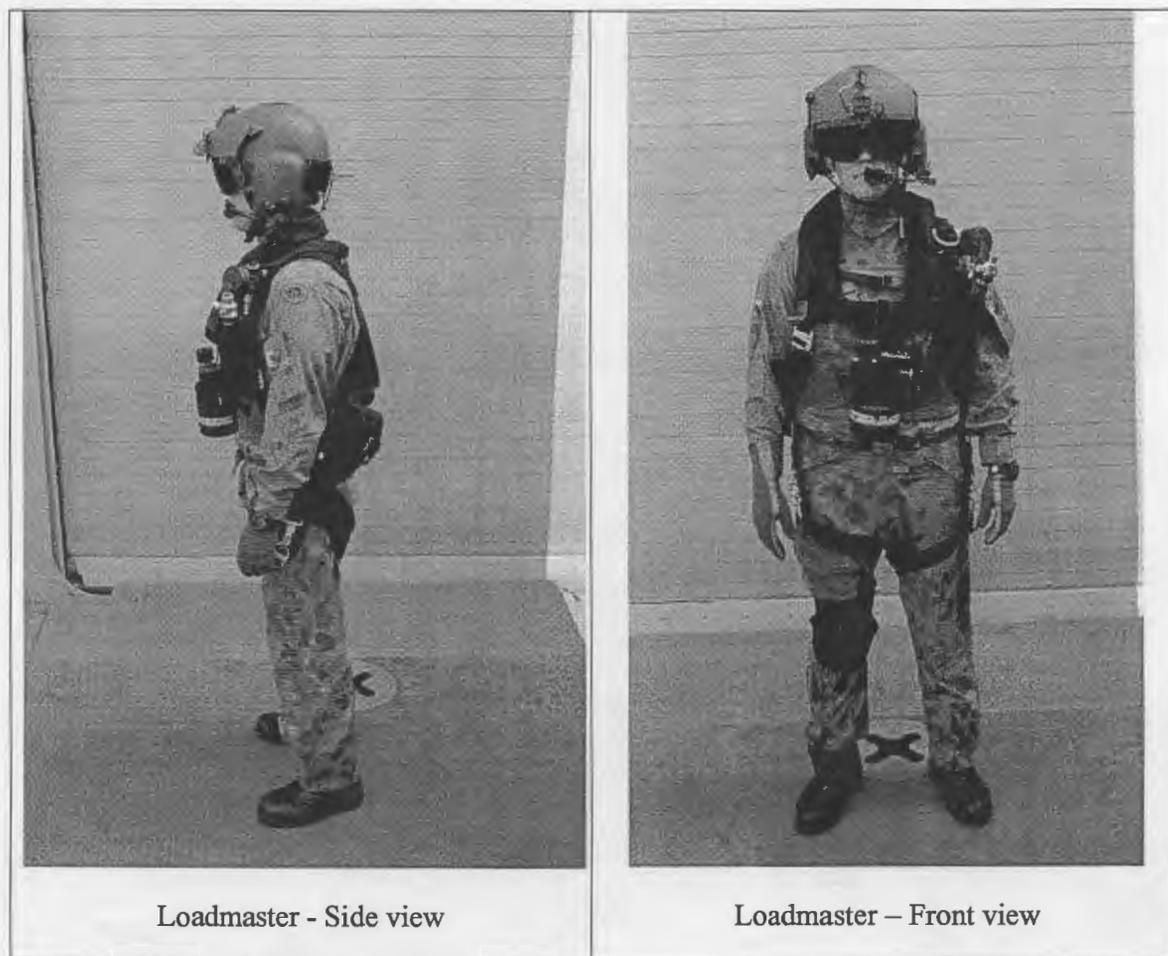
Figure 8. Loadmaster LSE

- c. **Left side loadmaster.** HGU-56P aircrew helmet slight damage, SALA International SO28 Loadmaster Harness with Secumar flotation collar activated, HABD bottle used, no HABD bottle strap, regulator mouthpiece twisted, ballistic vest complete, Ephese Aircrew Breathing System (ABS), full set flying clothing.

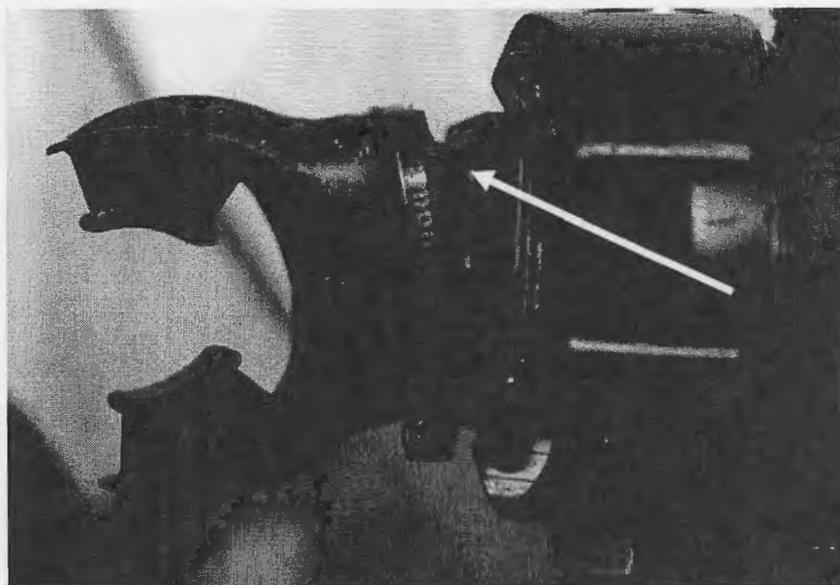
Figure 10. Mouth piece dislodged from regulator

33. **Security of mouth piece to regulator and HABD bottle.** A number of safety recommendations were made during the preliminary field investigations as reported via SITREP^{xvii} to the appointing authority. These recommendations related to the adequacy of aircrew and passenger life support equipment. Specifically, the security of the mouth piece to the HABD regulator (figure 7 refers) and the HABD bottle to the aircrew survival vest prompted the Army Aviation Support Project Office (AASPO) to issue two special technical investigations (STI) 379 and 380 to address these issues for Army Aviation aircrew. The HABD bottle was secured to the life preserver with either a simple pocket and neck strap (pilot), or a fitted adjustable pocket without a neck strap (loadmaster). In either case it appears the bottle can be dislodged easily from the life preserver, potentially increasing snag risk and loss of the HABD during egress. The AAIT was made aware^{xviii} of the of modification status to the loadmaster survival vest to address the security issue. The AAIT has been advised that the interim modification to the pilot LPSV requires further testing and evaluation.^{xix}

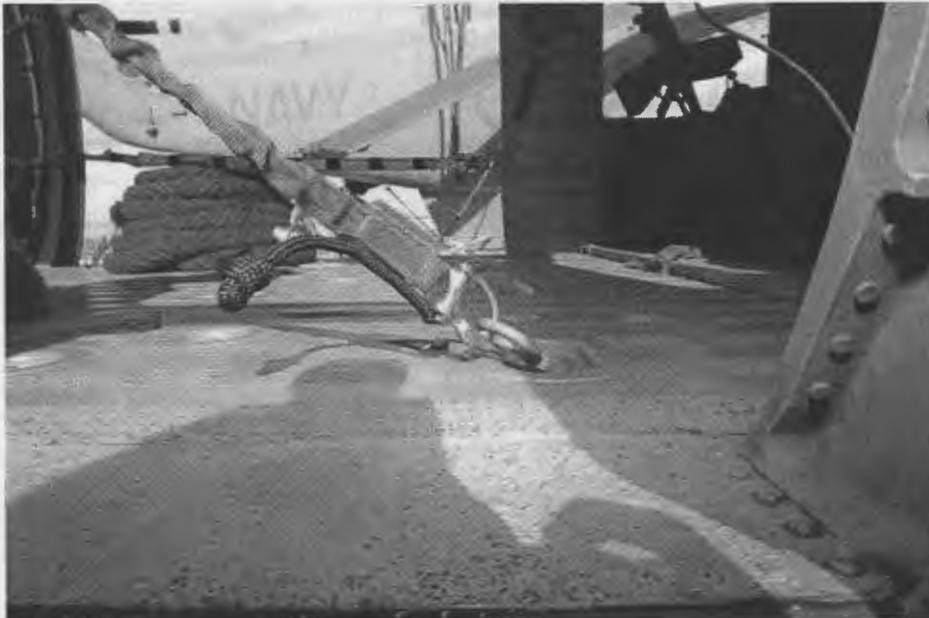
Figure 12. Example of HRS anchor points

39. **The HRS.** The HRS, although used by SO personnel, has not been through the formal approval process. The latest documentation, dated 14 Jul 06, examined by the AAIT indicates that design acceptance is being sought.^{xxiii} The HRS configuration for the passengers had two quick-release mechanisms to enable egress. The AAIT arranged a mock-up of the cabin layout and troop disposition of BLACK ONE whilst on-board HMAS KANIMBLA (figure 11), in order to gain an understanding of the passenger loading configuration and the use of the HRS (figure 12).

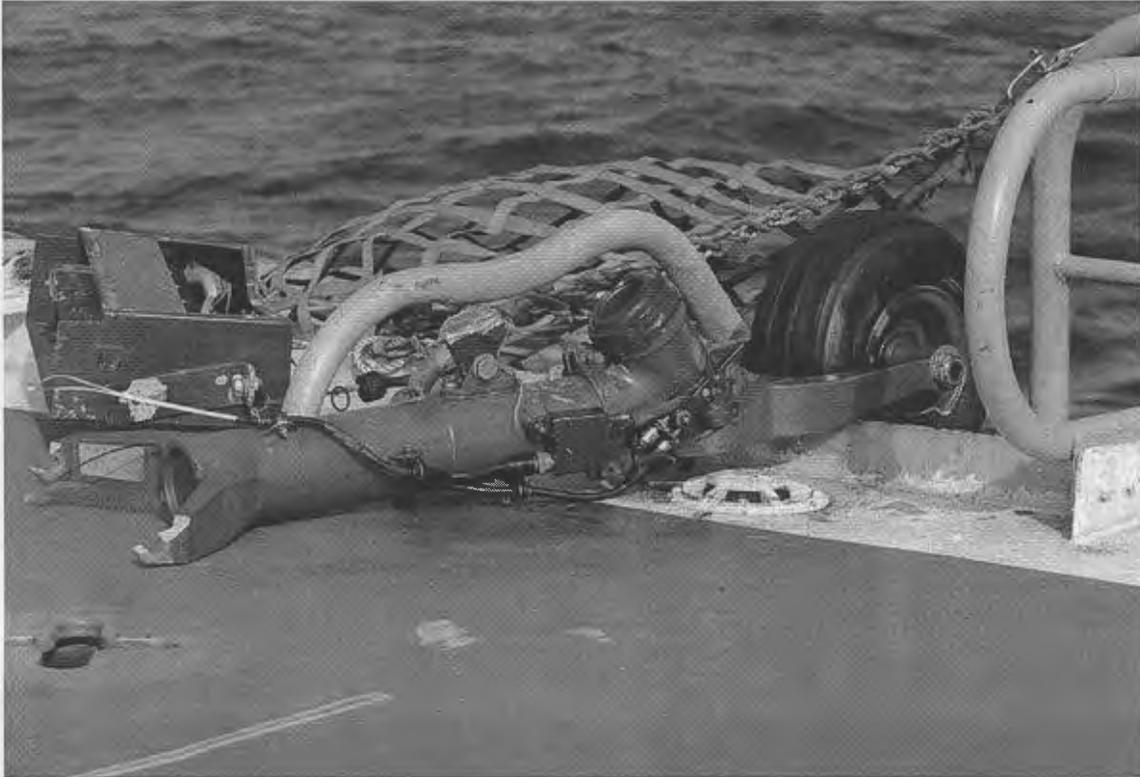
Figures 13. Tail wheel

41. Some aircraft wreckage was recovered from the surface of the ocean, the ship's sponsons and the aft flight deck. The largest component recovered was the tail wheel and strut as depicted in figure 10. Other components included shattered fibreglass pieces and splinters. Examination of these components did not reveal any pre-existing failures that may have contributed to the accident.

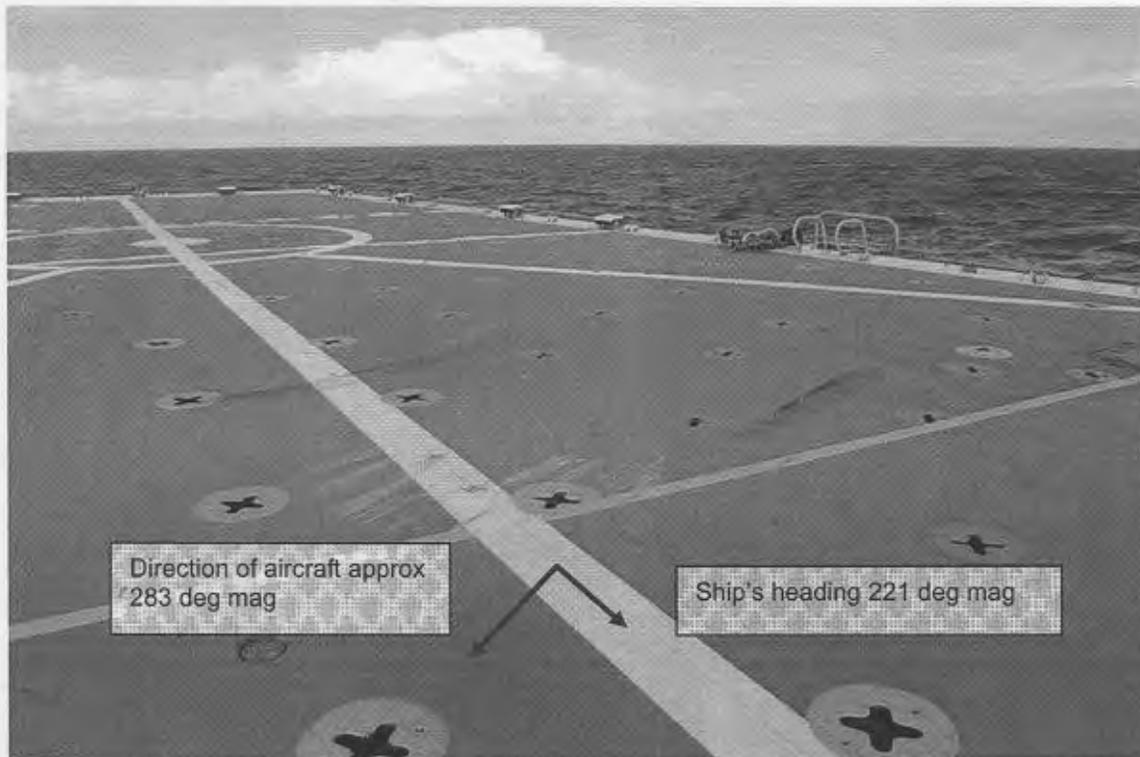
Figure 14. Impact marks on flight deck

42. HMAS KANIMBLA sustained minor damage (figure 11), consisting of tyre rub, scrapes and gouges to the flight deck, along with damage to the port side flight deck ladder and sponson.

43. Witness marks on the aft flight deck and analysis of the ship's closed circuit television (CCTV) indicated that the aircraft impacted in approximately 12 degrees left bank, with a nose down pitch of approximately 20 degrees. At the time of impact, the angle of the aircraft flight path to the ship's heading was noted as 62 degrees. This correlated to an aircraft magnetic heading of 283 degrees.

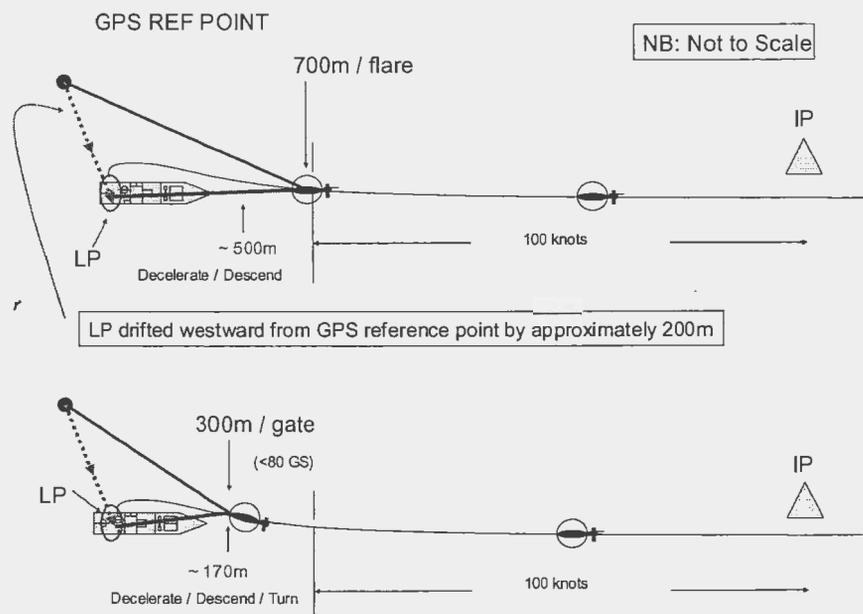
Figure 19. Diagrams of the drifting ship locations

80. There are a number of inconsistencies with the figures in that the ship appears to initially drift to the west and then back to the east. The rate of drift also varies from 4.8 knots to 1.1 knot depending on which points are used. Furthermore, the position of the accident as noted by BLACK TWO is 2.6 nm different to that of HMAS KANIMBLA. The AAIT was therefore not able to conclusively state the rate of drift; however it was acknowledged that with a westerly sea current of 0.75 knots and an easterly wind of 10-15 knots, the ship would be expected to drift to the west. This was confirmed by the crew of GOLD ONE, who had noted that the ship had drifted approximately 400 metres to the west of the original GPS waypoint logged on departure some 30 minutes earlier.
