MINUTE PAPER

GANNET AIRCRAFT S/N<sup>o</sup> XA 332

BOARD OF ENQUIRY

**REPORT ON AIRCRAFT ACCIDENT**

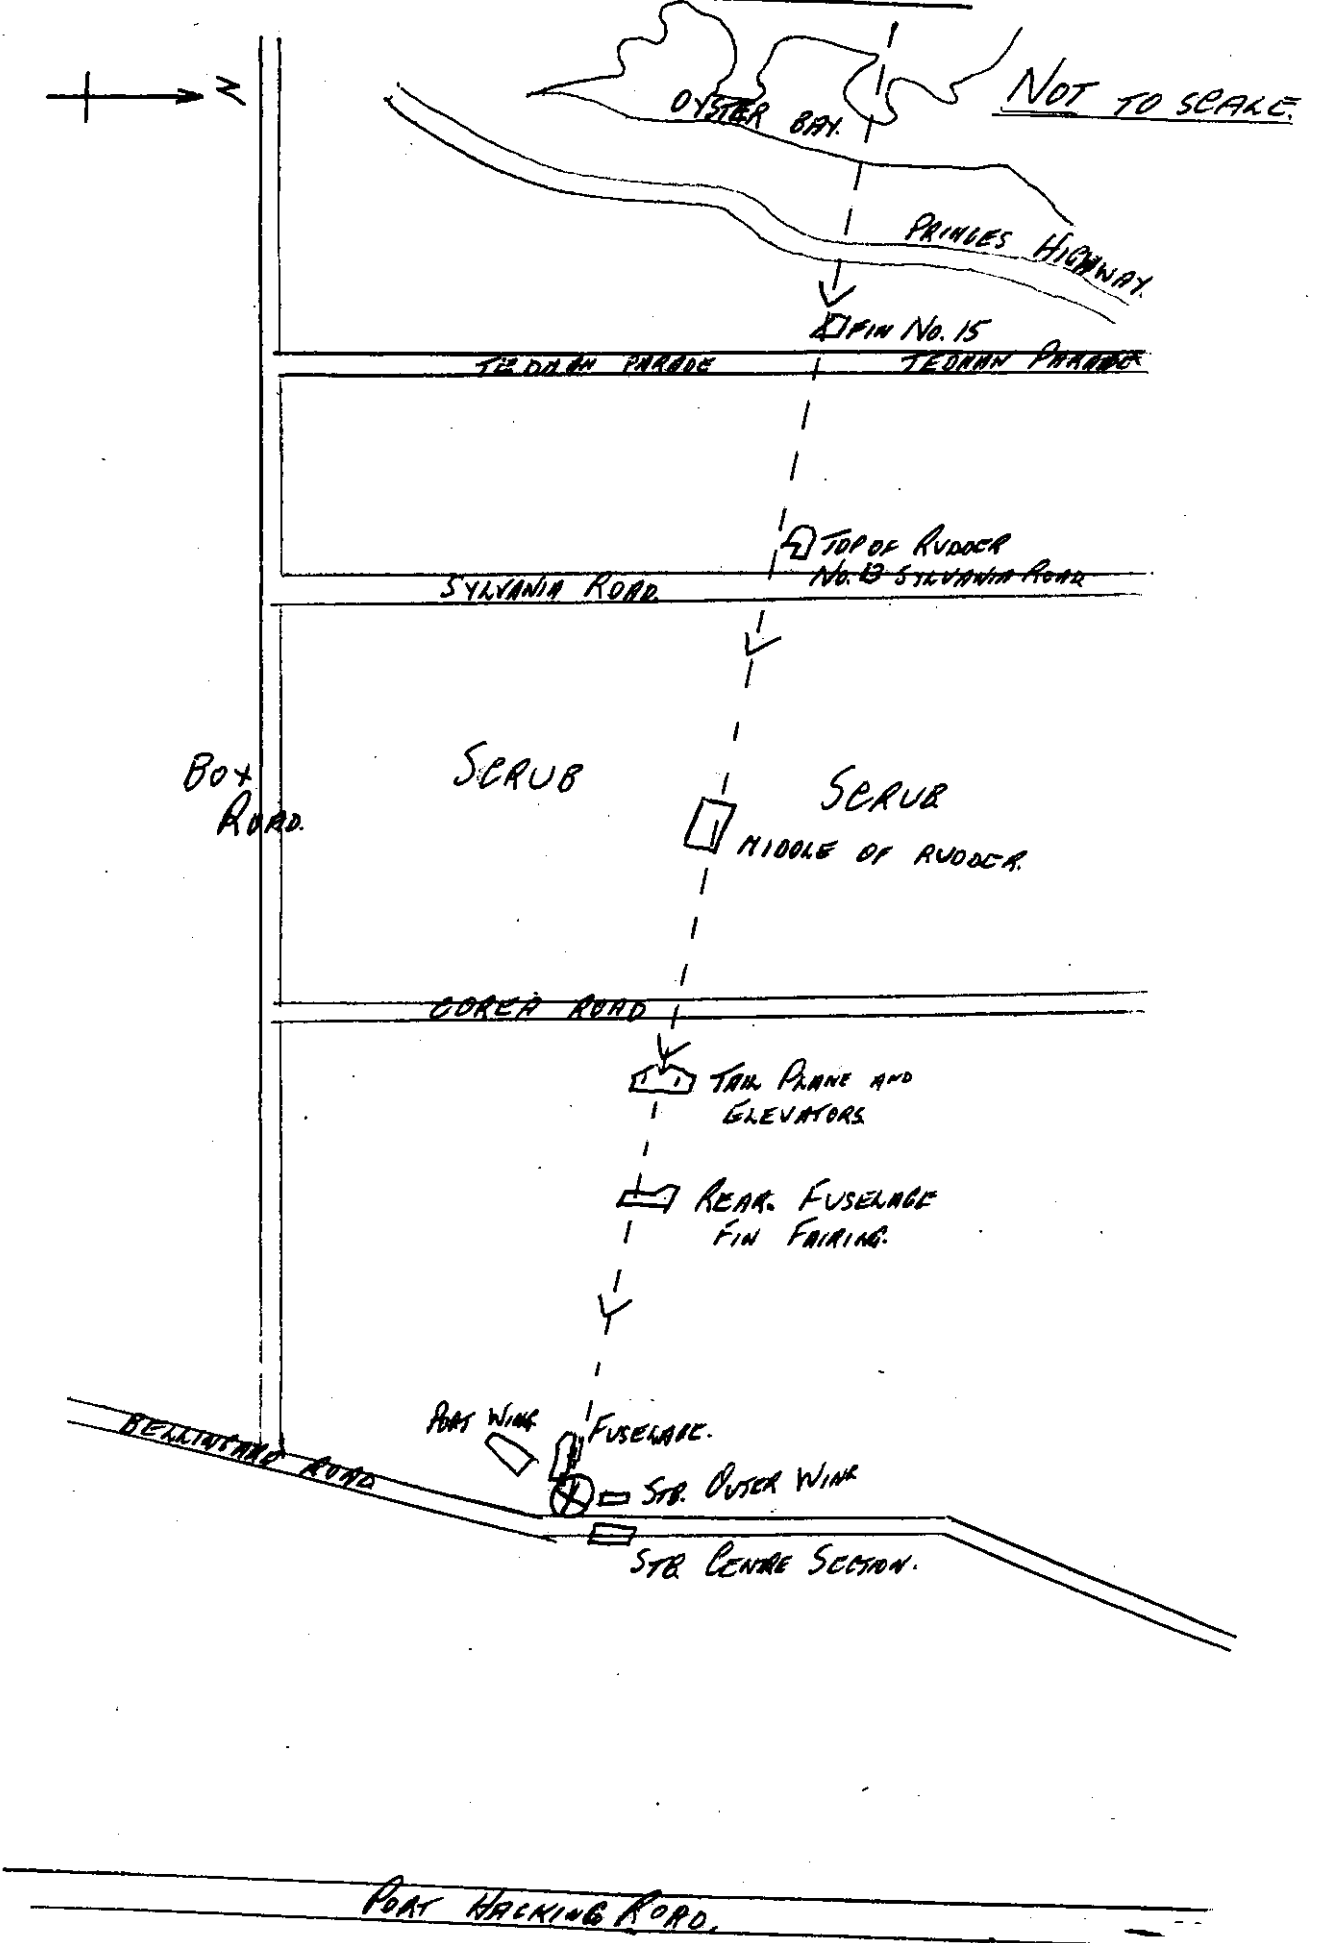
DIAGRAM OF TAIL UNIT PIECES.

as before. Shortly after this when nearing Prince's Highway, the tail unit of the aircraft commenced to break up. A total of 5 pieces were observed to fall from the aircraft in what appeared to be the following order:-
