Skyhawk 885

N13-154906

Ramp Strike aboard HMAS Melbourne 01 Sept 1971 – Phil Thompson

Ditching - 21 October 1980.

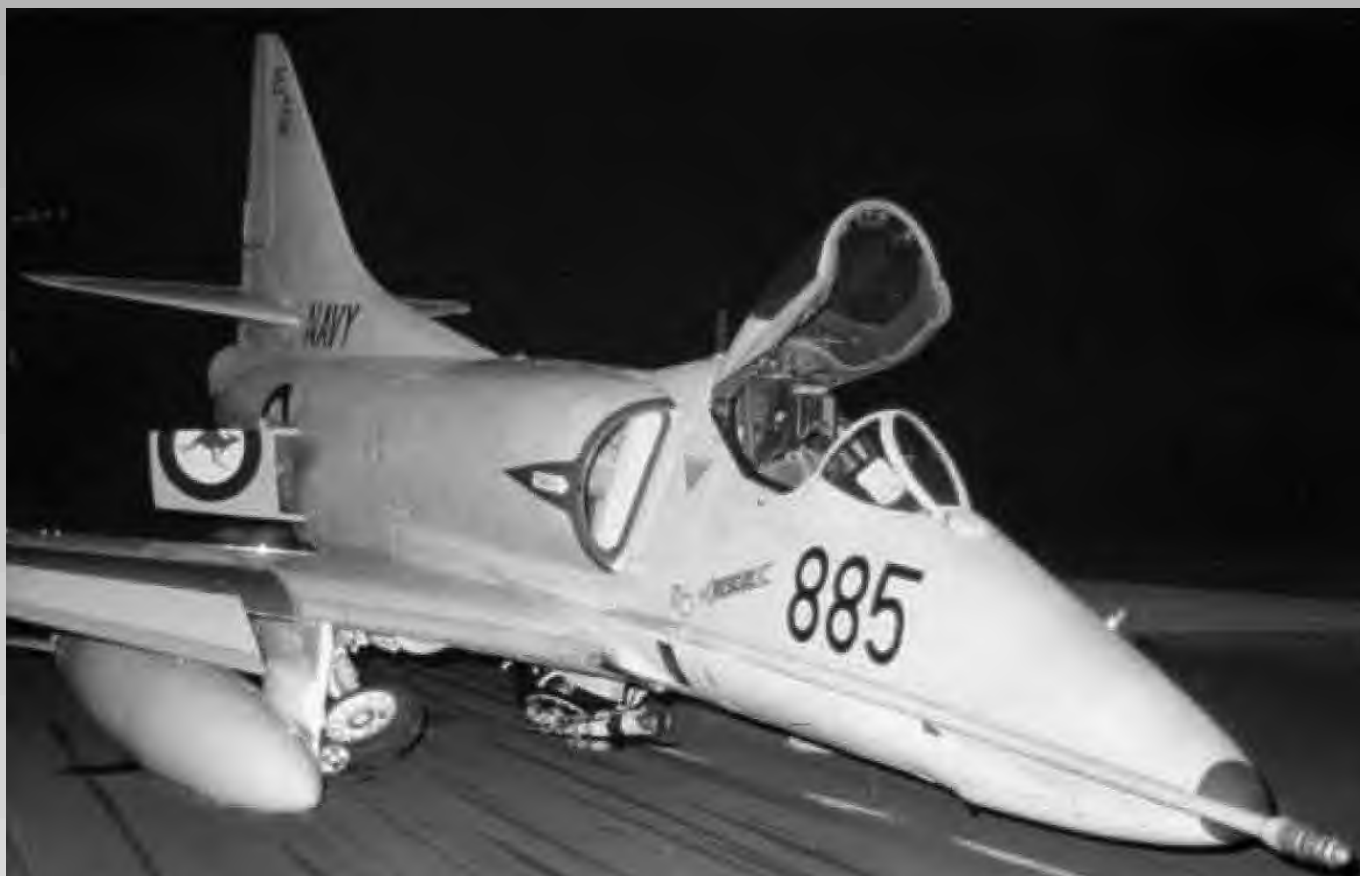
Above.. On the night of 01 September 1971 SBLT Phil Thompson struck HMAS Melbourne's ramp during a night deck landing. The aircraft was severely damaged by he diverted to NAS Nowra for an emergency recovery, thereby saving the taxpayer the cost of a Skyhawk. You can read his full account of the incident below, and see some associated diagrams and pictures [here](#).

Of course there was an almighty bump as the wheels hit the deck and the U/C flexed so much that the inner brakes gouged the steel deck before the U/C broke — but I was going UP at the time — if I had still be going down it would have been all over. Thank goodness for relative motion etc.

Later I heard about what this event looked like from those on the ship. They said the shower of sparks was amazing, as the steel met steel. I was lucky also that the undercarriage leg stubs did not catch a wire, that would have been catastrophic. So I was airborne again before reaching the No. 1 wire. You can see on the photo how the black tyre marks start/stop and the gouges of the brake mechanism (inside the wheel) on the steel deck (before it broke, along with everything else related to the U/C). [Later I was told that paint marks from the drop tank fins were on the deck but painted over quickly - so I never saw them myself.]

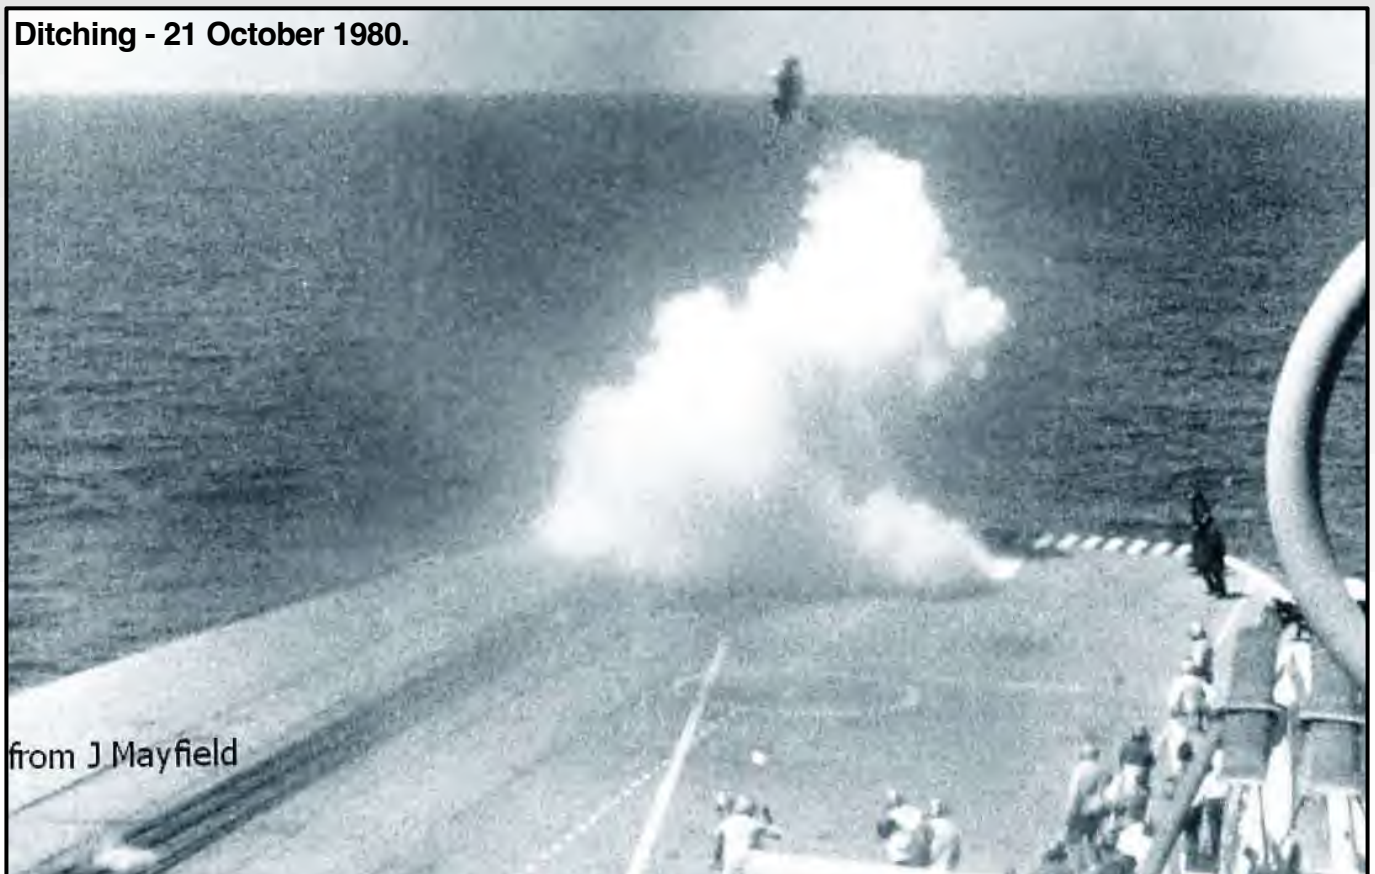
Previous page. SBLT Baddams ejecting from 885 as the aircraft is dragged over the bow by a defective catapult shot. The subsequent Board of Inquiry considered the most likely cause was that the catapult track steam valves were not shut down during the launching sequence, brought about by the desire of the catapult crew to meet the planned launch time. You can read an account of the accident, including a statement by the pilot, [here](#).

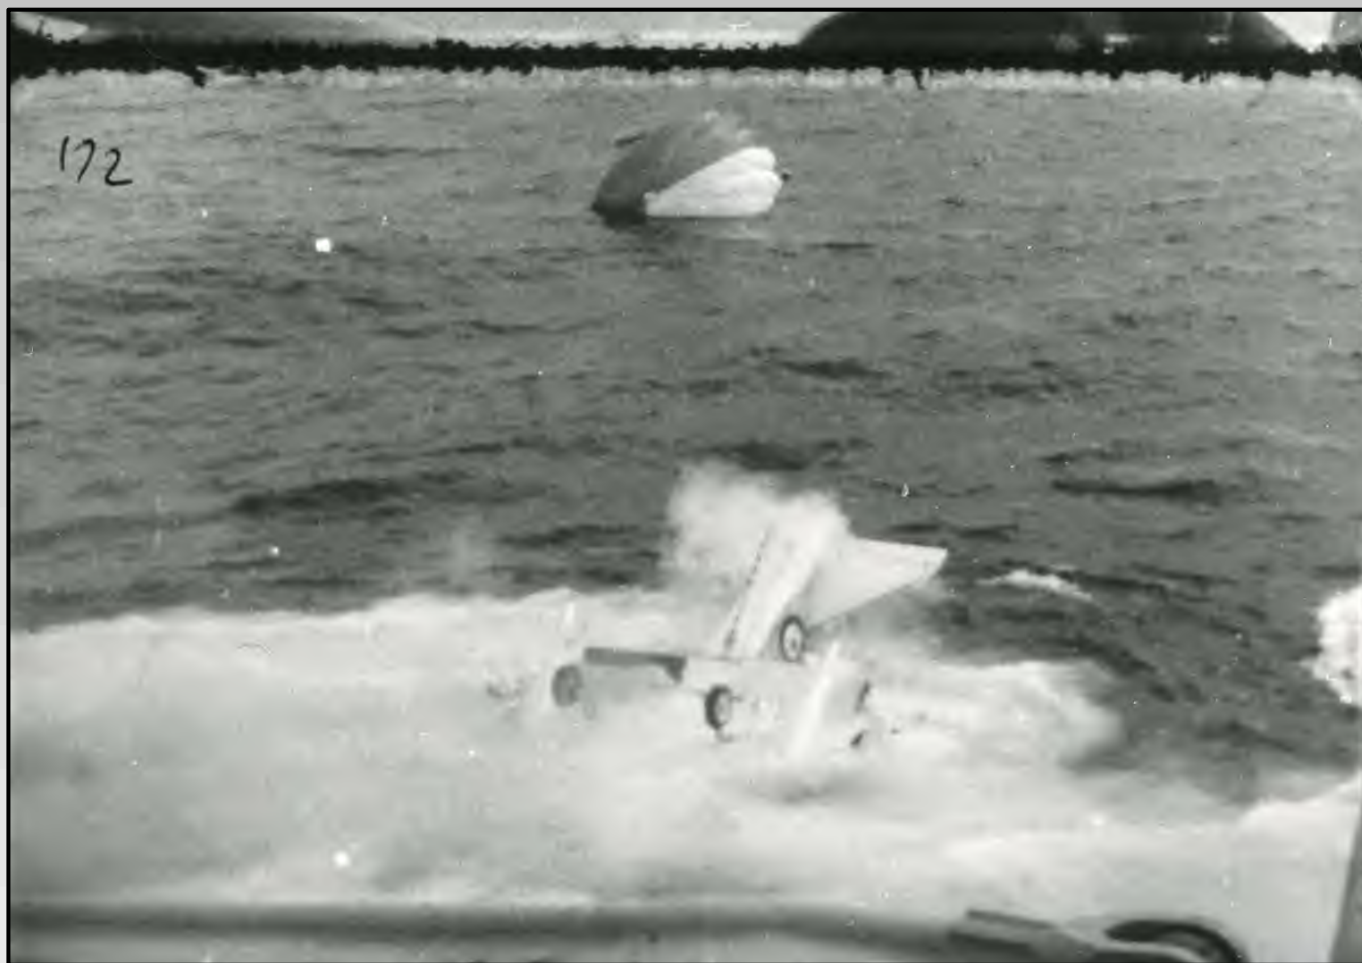
Below. The last sight of 885 as it sinks in deep waters off Sri Lanka. Baddams' parachute canopy can be seen not far away (Navy image).
