RAN A4G Night ramp strike story — a series of notes and images, added over a year or so — explains various points about this event — 01 September 1971

Ramp Strike aboard HMAS Melbourne 01 Sept 1971 – Phil Thompson

Aftermath from night DL 01 Sep 1971

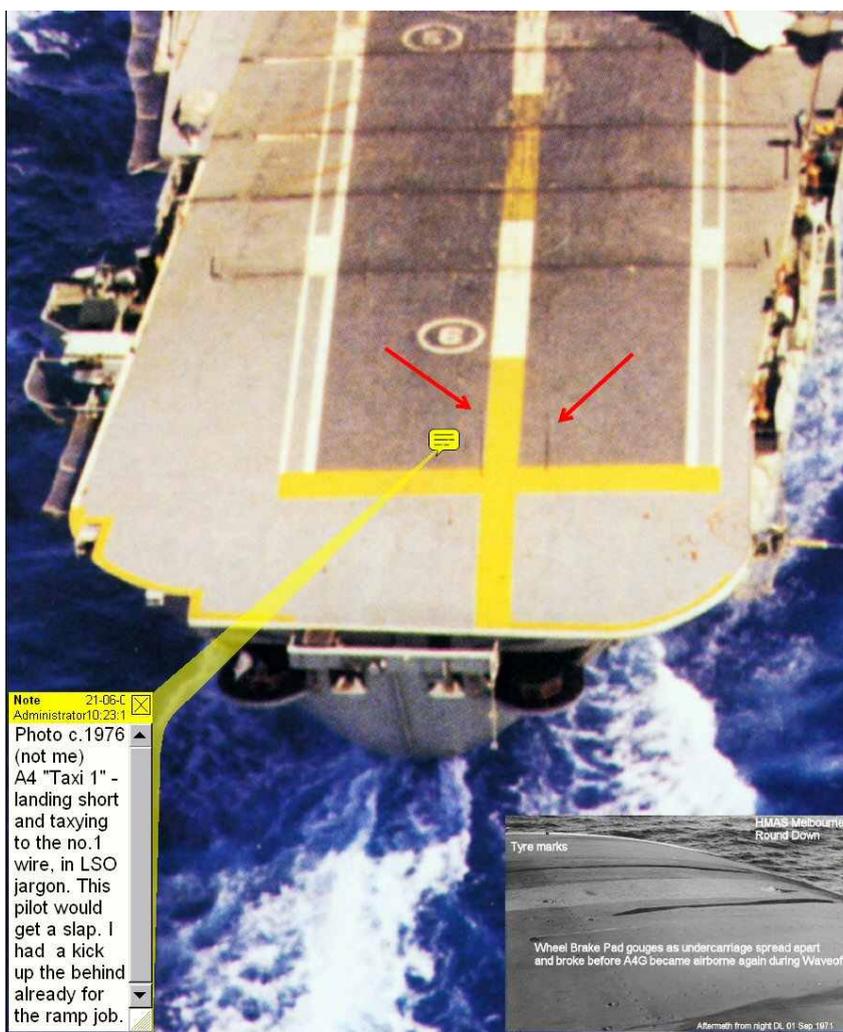
Later I heard about what this event looked like from those on the ship. They said the shower of sparks was amazing, as the steel met steel. I was lucky also that the undercarriage leg stubs did not catch a wire, that would have been catastrophic. So I was airborne again before reaching the No. 1 wire. You can see on the photo how the black tyre marks start/stop and the gouges of the brake mechanism (inside the wheel) on the steel deck (before it broke, along with everything else related to the U/C). [Later I was told that paint marks from the drop tank fins were on the deck but painted over quickly - so I never saw them myself.]

As mentioned on the ADF site, it was a year before the A4 could be mended with a permanent (acceptable) bend in the airframe. I recall I was supposed to take it on the first (squadron) test flight, but this flight was cancelled due to bad weather and subsequently someone else took it up.

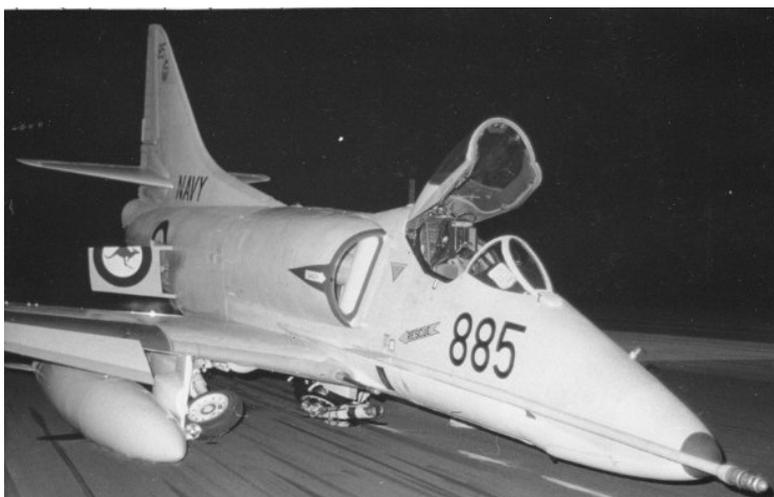
The aftermath:

Of course there was an almighty bump as the wheels hit the deck and the U/C flexed so much that the inner brakes gouged the steel deck before the U/C broke — but I was going UP at the time — if I had still be going down it would have been all over. Thank goodness for relative motion etc. [Photo of ramp damage + diagram](#)

HMAS Melbourne Round Down
Tyre marks

Wheel Brake Pad gouges as undercarriage spread apart and broke before A/G became airborne again during Waveoff

← Further up the deck were twin paint marks from the drop tank fins scraping the deck. The tanks were not breached though. The marks stopped before No.1 wire though.

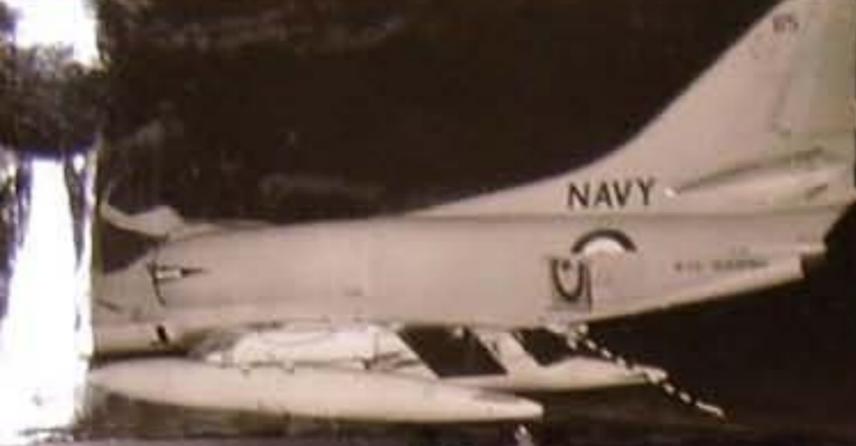
JET FIGHTER BOUNCES OFF FLIGHT DECK

A Skyhawk jet fighter wrecked its undercarriage in an abortive night landing attempt on HMAS Melbourne on Wednesday, the Navy said yesterday.

The pilot gave the jet full throttle in a split-second reaction and lifted the fighter back into the air from the carrier flight deck.

The jet was on Wednesday night was attempting its first night landing aboard Melbourne. The jet bounced off the flight deck and then flew for about a mile. The carrier was at sea at the jet's intended to be the base at Whitt, Alaska, Alaska.
