DEPARTMENT OF DEFENCE
DEFENCE SCIENCE AND TECHNOLOGY ORGANISATION
AERONAUTICAL RESEARCH LABORATORIES

Aero Propulsion Report 175

REPORT ON GAZELLE ENGINE SEVENTH
STAGE COMPRESSOR BLADE FAILURE

D. E. GLENNY

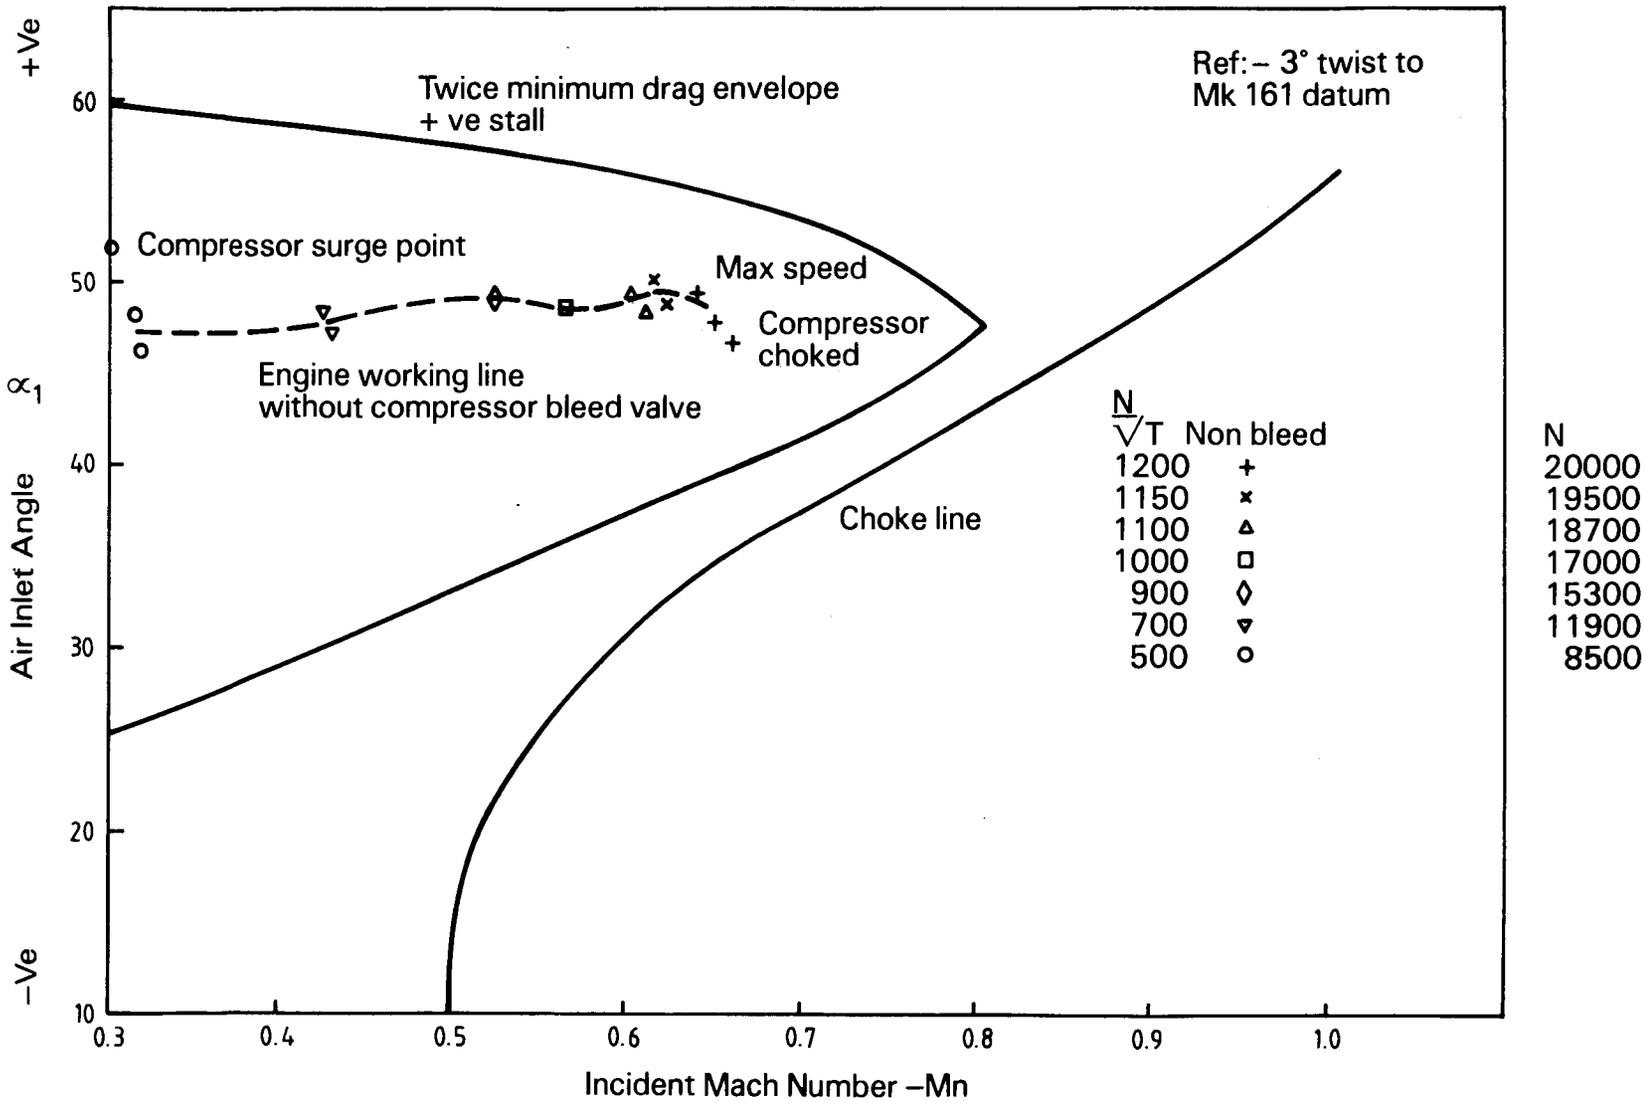
engine operating line with respect to the 7th stage cascade choke line and the stall line or twice minimum drag envelope. This presentation is typical of the procedures used in the late 1950's to assess flutter boundaries. It owes its development in part to the work of Carter, Reference 23, in which the boundaries are related to the cascade maximum and critical Mach Numbers. Figure 10 defines these boundaries in terms of flutter free and flutter prone areas. As can be seen from Figures 9 and 10, the nominal operating line of the Gazelle engine (for the 7th stage) is well within the flutter free boundary for all engine speeds, even when the compressor as a unit is choked. From this type of analysis it is not possible to determine the effects of misscheduling the VIGVs on blade flows and consequently blade flutter, however effects of changes to VIGVs would be more marked in the first and second stages. The fact that the Rolls Royce and ARL tests of References 11 and 15 which carried out experiments with gross misscheduling of the VIGVs did not overtly encounter flutter can be indicative of the fact that the occurrence of flutter is not a significant problem for the 7th stage compressor row, and maybe for the whole compressor. It should be noted that the flutter assessment techniques used for the Gazelle are not representative of current aero engine practice; the problem is much more complex than analysis by simple cascade theory. However due to the age of the engine, and lack of specific component data it is not possible, nor in this case warranted to establish the boundaries more accurately.

FIG 9 GAZELLE 7TH STAGE COMPRESSOR BLADE ROW
FLUTTER BOUNDARIES AND ENGINE OPERATING LINE

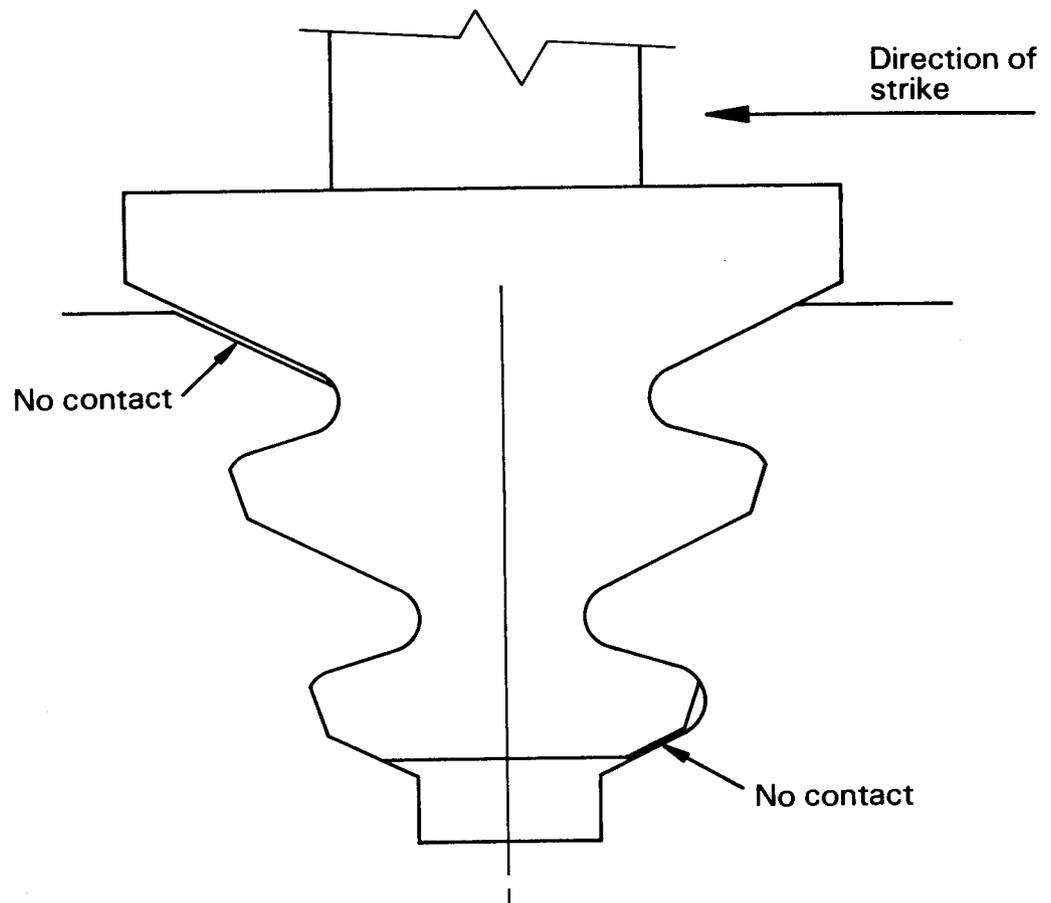
FIG 2 BLADE ROOT FITS FOR BLADES NOS 35 & 36
COMMERCIAL-IN-CONFIDENCE

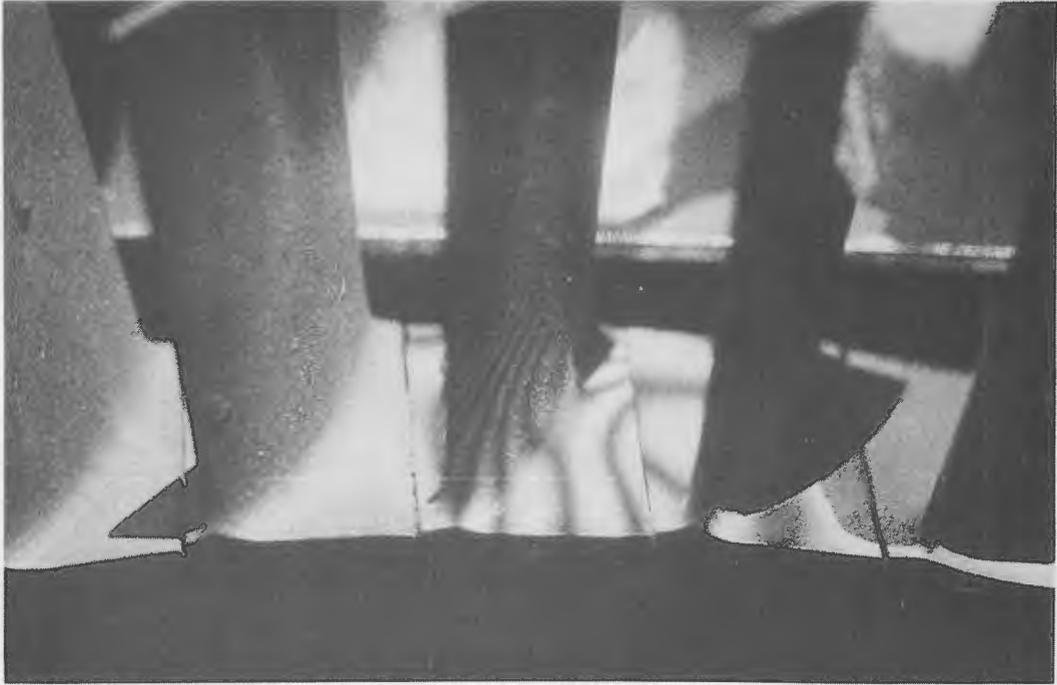
FIG. 7 END-ON VIEW (BLADE PAIRS 19/20)

A comparison of the end-on views of the left blade in the pairs of nominally good blades (selected at random), (Figures 7, 9 and 11) shows that their response to the applied load is similar. However, for the right blades, whilst Figures 7 and 11 are similar, in Figure 9 the fringe pattern resembles the fringes in the ill-fitting case (Figure 5), although not as many fringes are observed. Further indication that this blade is undergoing greater than normal displacement can also be seen in a comparison of the side on views (Figures 8, 10 and 12).
