DIRECTORATE OF DEFENCE AVIATION AND AIR FORCE SAFETY

AIRCRAFT ACCIDENT INVESTIGATION REPORT

**LOSS OF BLACK HAWK A25-221
EMBARKED IN HMAS KANIMBLA, NEAR FIJI
29 NOV 06**

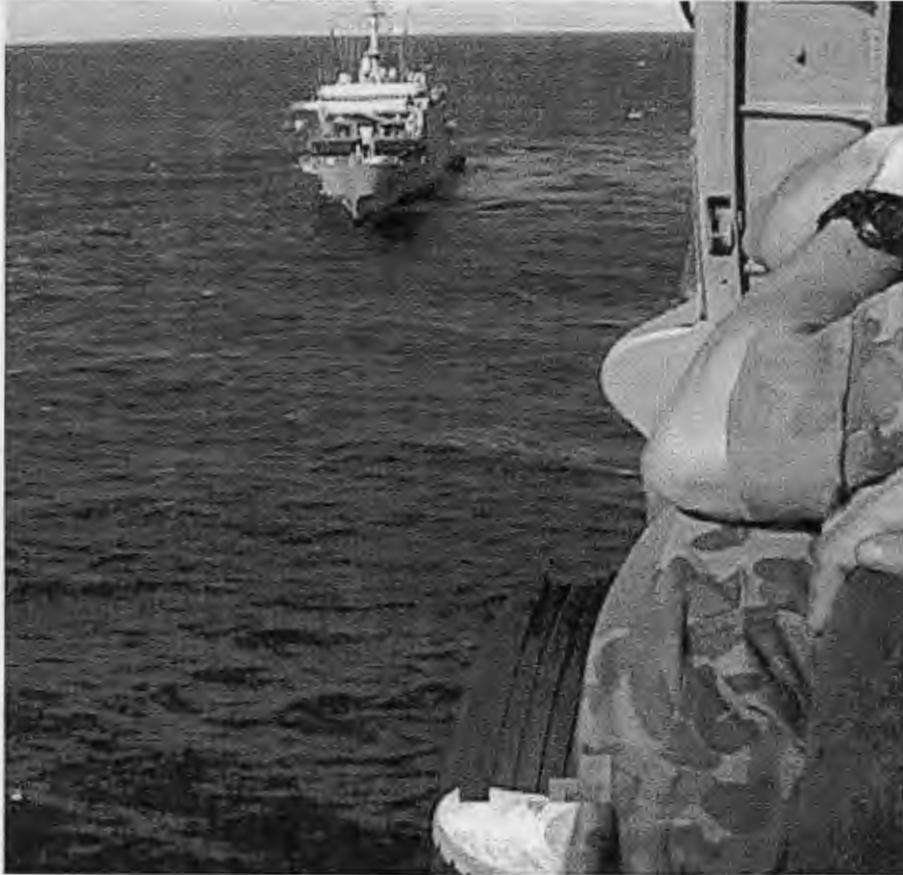
Figure 1. Image captured from in-flight digital hand-held camera

16. At approximately 1607 hours, BLACK ONE commenced its run-in from the IP. Figure 1 is an image captured from the final usable frame of a hand held video camera during the approach and moments before the ship's forward looking camera recorded the aircraft approach the ship from ahead and then pass along the port side at 16:10 hours^{vii} (figure 2).^{viii}

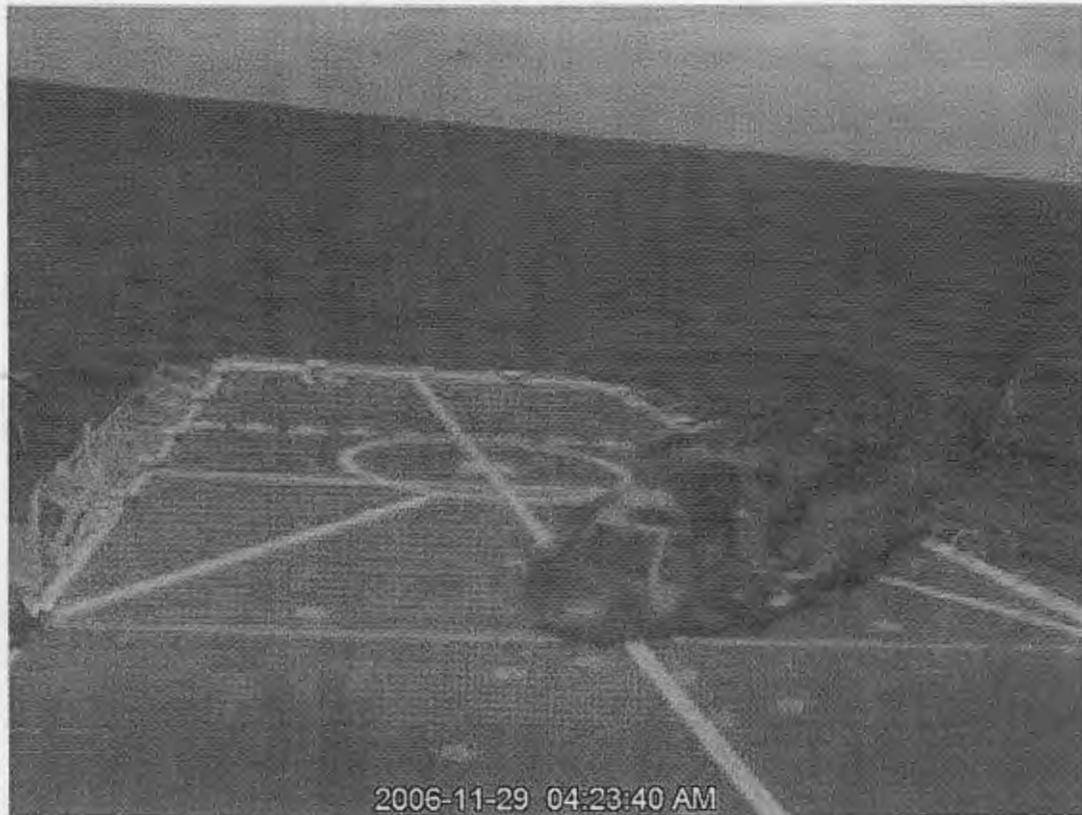
Figure 3. Image captured from the aft flight deck camera⁷

17. The aircraft was similarly observed by eye witnesses to approach the ship from ahead, commence a decelerative flare, pass along the port side of the ship, and turn left toward the flight aft deck. The aircraft, at the completion of the left turn, and as recorded by the ship's aft looking camera, proceeded to descend toward the aft flight deck, impacting the deck mid-way between number two and three landing spots. Figure 3 is an image captured from the aft looking CCTV as the aircraft enters the field of view over the aft flight deck. Figure 4 is a diagram of the flight track with respect to the ship.

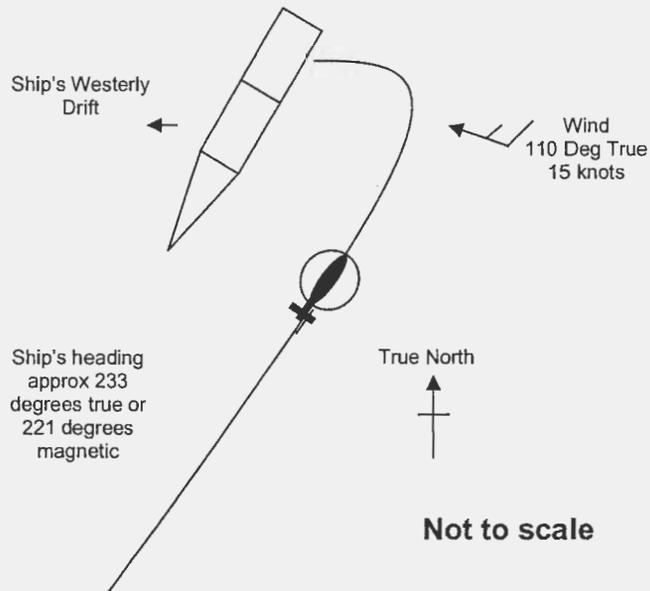
Figure 4. BLACK ONE's flight profile

18. During the accident sequence, the fuselage impacted the flight deck, whilst the tail boom and rotor separated from the aircraft after colliding with the edge of the flight deck, falling over the port side of the ship. The remaining fuselage section became airborne, rotating and transitioning laterally across the flight deck, eventually falling into the ocean on the starboard side of the ship.

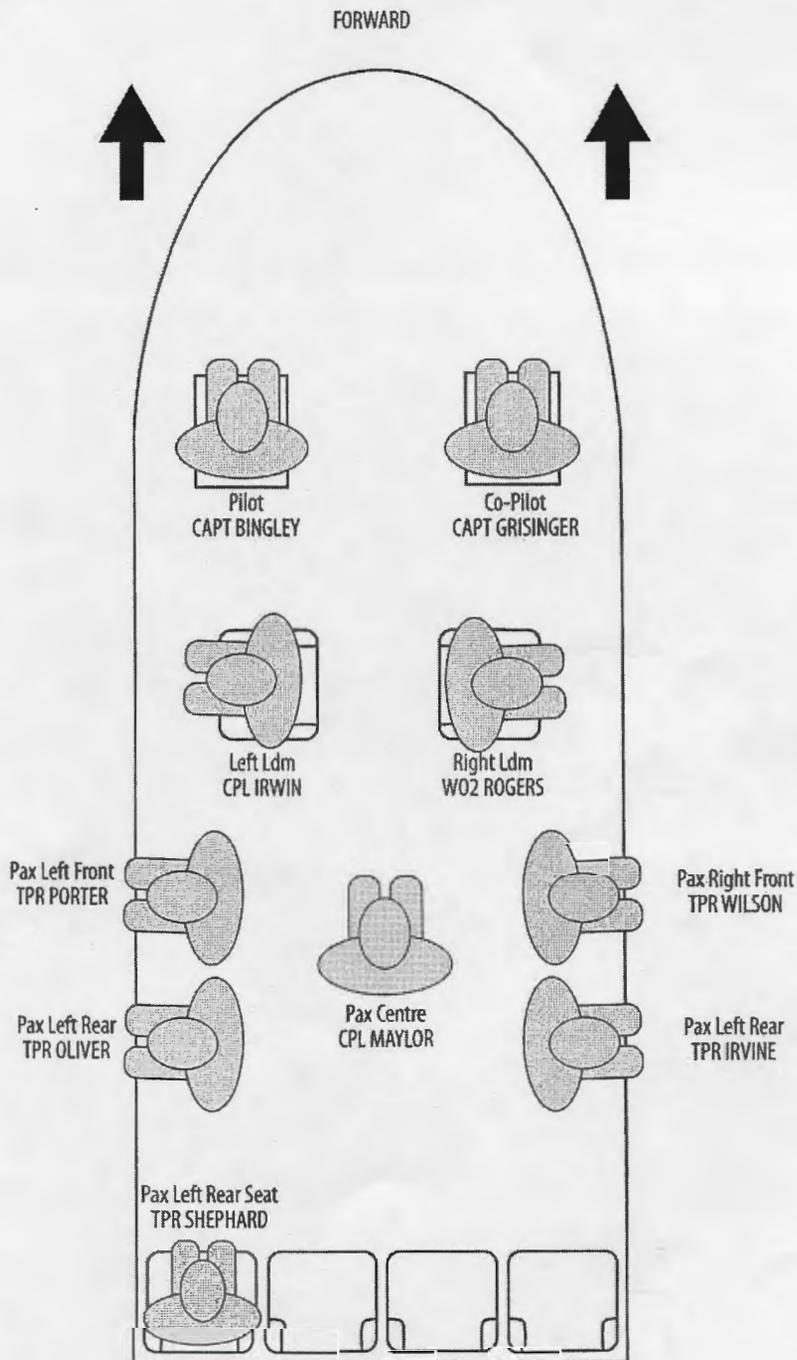
Figure 6. Crew and passenger positions in BLACK ONE at the time of the accident

23. The seating arrangements in the aircraft at the time of the accident are depicted in figure 6.

Position	Name	Injuries and status
L Pilot station	CAPT Bingley	Drowned; Abrasions to nose, chin, L knee, R leg. Bilateral haemorrhage in middle ears. Internal haemorrhage around larynx
R Pilot station	CAPT Grisinger	Bruise L elbow, tongue bite, walking
L Ldm	CPL Irwin	Soft tissue injury (STI) R buttock, abrasion R flank, bruise behind L knee, walking
R Ldm	WO2 Rogers	STI thoracolumbar spine, L scapula, R knee, L wrist, L ankle, sitting/litter
Pax L front	TPR Porter	Missing, presumed dead
Pax R front	TPR Wilson	STI lumbar spine and buttocks, walking
Pax centre	CPL Maylor	Facial cut, bruising, minor head injury, sea water aspiration, walking
Pax L rear	TPR Oliver	T12/L1 crush fracture 50%, litter
Pax R rear	TPR Irvine	Sacro-coccygeal injury, suspect L rib fracture
Pax L rear seat	TPR Shephard	STI back, litter

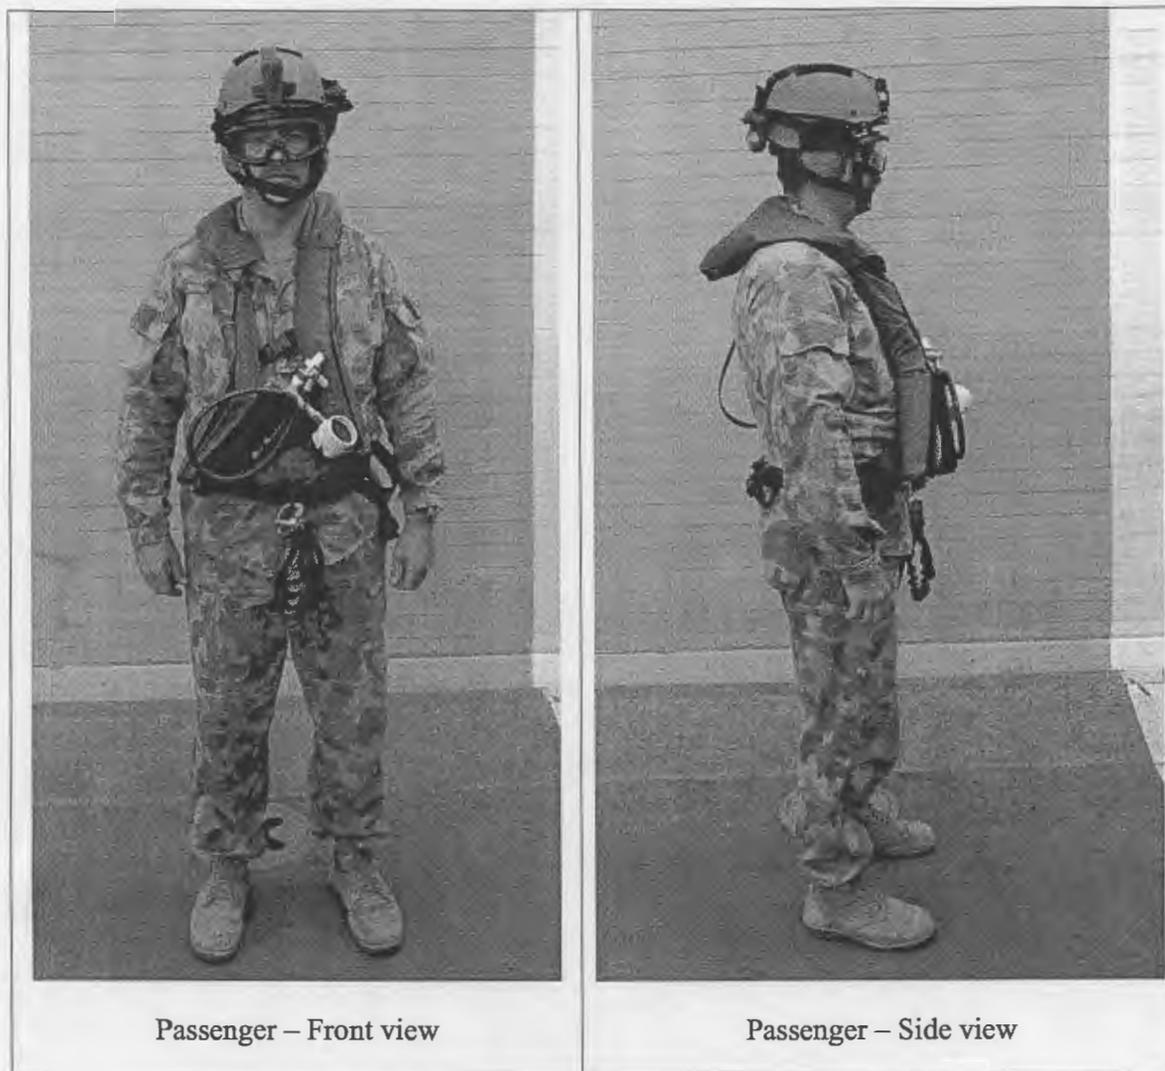
Figure 9. Passenger LSE

29. Further analysis of the LSE is to be performed by AESSO ALSE and AVMED at RAAF Base Edinburgh. This will be provided as a separate report to the Appointing Authority.

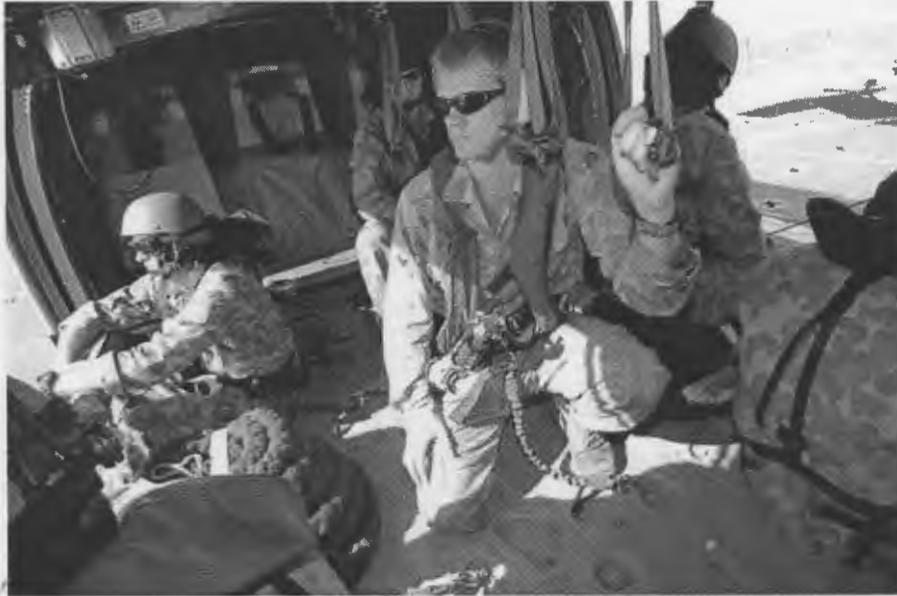
Figure 11. Mock-up for passenger loading, cabin view looking aft

39. **The HRS.** The HRS, although used by SO personnel, has not been through the formal approval process. The latest documentation, dated 14 Jul 06, examined by the AAIT indicates that design acceptance is being sought.^{xxiii} The HRS configuration for the passengers had two quick-release mechanisms to enable egress. The AAIT arranged a mock-up of the cabin layout and troop disposition of BLACK ONE whilst on-board HMAS KANIMBLA (figure 11), in order to gain an understanding of the passenger loading configuration and the use of the HRS (figure 12).

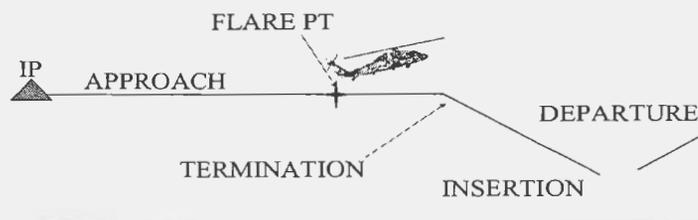
Figures 15. Four phases of assault approach

96. The assault approach is broken into four phases (shown at figure 12); the approach, termination, insertion and departure. The phases of the procedure applicable to the investigation were the approach and termination.

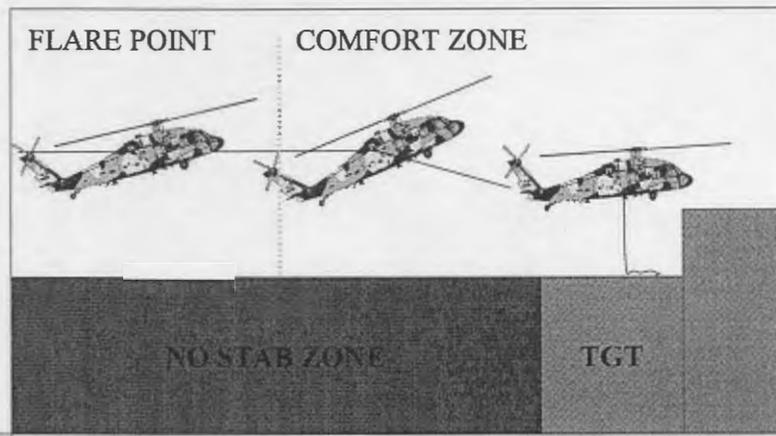
Figures 16. Assault termination

" $\frac{1}{4}$ of the deceleration in the termination is conducted in the last $\frac{1}{4}$ of the distance. As you approach the last $\frac{1}{4}$ of the distance to run you enter the "comfort zone". As you approach the comfort zone you must be at a height and groundspeed combination that you can guarantee successful termination over the LP."
