Introduction: The Geopolitical Situation

A New Breed Of Aircraft

In 1945 the Fairey Aviation Company set about designing a new aircraft in response to a request from the Royal Navy (RN) for an advanced carrier-borne ASW aircraft powered by a turbo-prop engine. The prototype took to the air in September 1949, and after successful trials a large order was placed for this advanced aircraft. In 1953 the Gannet AS-1 began rolling off the assembly line.

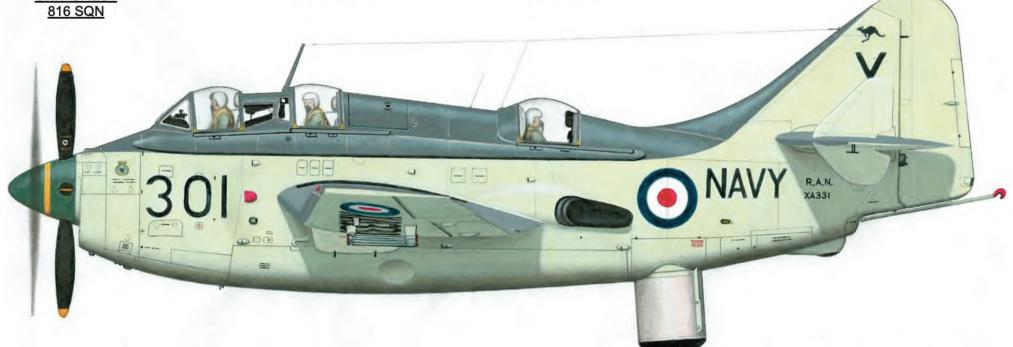
Above. This beautifully rendered graphic by John Best captures the main features of the Fairey Gannet. It is shown in the livery of 816 Squadron in August 1956, three months after arrival in Australia. The aircraft is in patrol mode with the starboard engine secured and its associated (aft) propeller feathered. The search radar under the aft fuselage is also extended. Note the "Y" on the tail, denoting the aircraft is attached to HMAS Melbourne, is partially obscured by the empennage. (John Best Aviation Art). +

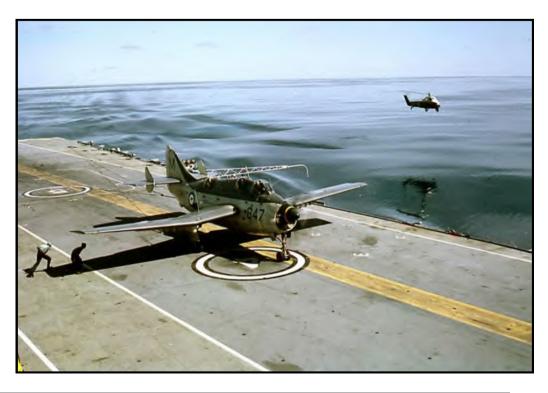
Below Left. With catapult strop in place (but not yet tensioned) and hydraulic chocks engaged, Gannet 312 is in the initial stages of a launch. Right: Same place, different time! Gannet 847 comes to a halt after an arrested landing. Notice the planeguard helo is now a Wessex, rather than the Sycamore in the first image. The two sailors approaching the aircraft will ensure the arrestor cable is detached from the tail hook before the aircraft is allowed to move forward. →

"The Melbourne had the most sophisticated catapult I saw on any ship. It was fitted with loading chocks which had a set of rollers which centred the aircraft on the catapult centre line after it was stopped by the chocks. Once the strop and "holdback" were put in place by the handlers the loading chocks were lowered and the aircraft allowed to roll forward until the holdback was restraining it but, while the catapult was being tensioned up a further set of "breakout" chocks prevented the aircraft rolling forward if the holdback broke prematurely. This arrangement allowed the Melbourne to launch aircraft as fast as most carriers with two catapults."

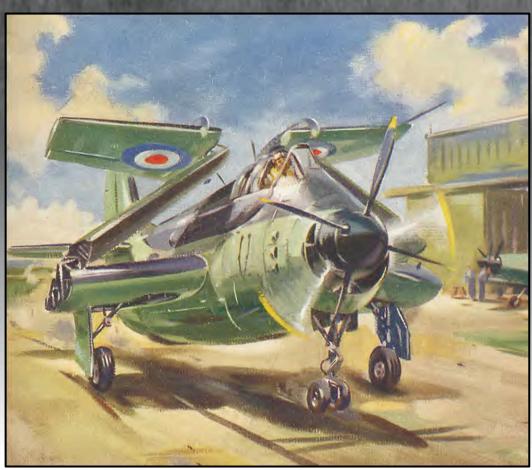
Above: This image of a painting by Laurence Bagley is of what seems to be the second Fairey Gannet prototype. Still no third cockpit nor fins on the tailplane but it did have three intakes on the engine cowling and wing 'fences' which were being trialled. It took until the third prototype before the definitive shape of the production Gannet was truly evident, with finlets on the tailplane, a third cockpit and a repositioned radome (which had been one of the causes of earlier instability). These modifications gave the prototype an edge over the Blackburn and Shorts competitors, and resulted in an order for 100 AS1 production aircraft. (Image courtesy of Zbigniew Patynowski).

The first Gannet prototype, VR546 known as the "Type Q" flew for the first time in September 1949. It had no third cockpit or auxiliary fins on the tailplane. It was not without teething problems, with stability and trim difficulties contributing to its crash during take off in November 1949.

The Gannet became the first turbo-prop aircraft to land on an aircraft carrier in June of the following year, when it undertook trials on HMS Illustrious. It was also the first to fly with twin-turbines driving contra-rotating propellers through a co-axial shaft. (Inset:Sir Richard Fairey, 1887-1956).

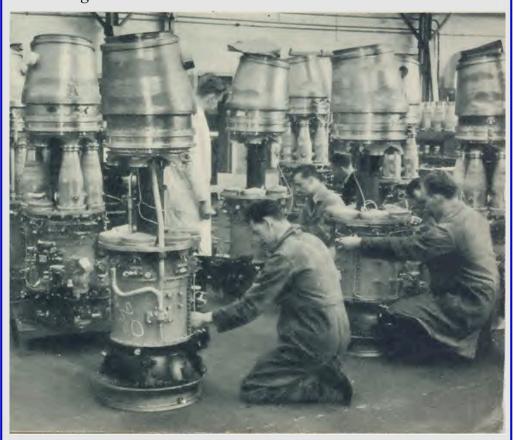
Below: Armstrong-Siddeley Double Mamba production, circa 1950. Photo: Flight International. →

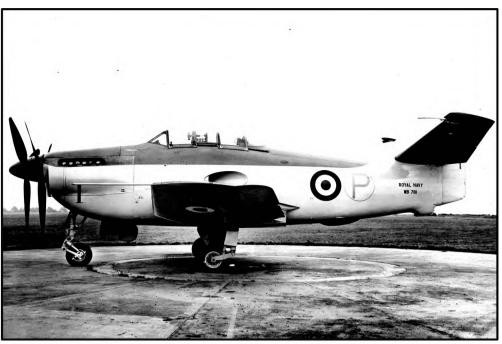
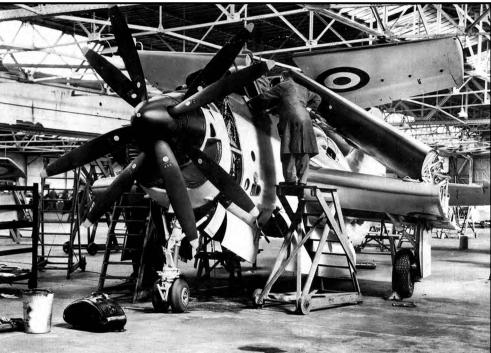
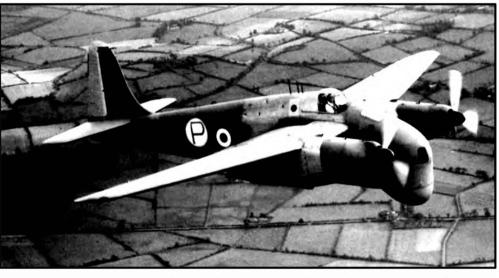
The Contenders

Top. Blackburn Aircraft and Motor Co., the only serious rival to Fairey, developed the Y.A.5 (later changed to Y.A.7), powered by a Rolls-Royce Griffon 56 engine driving contra-rotating propellers. This was a substitute powerplant, as the original Napier Double Naiad turbo-prop failed to achieve production. Three prototypes were built and when the aircraft failed to win the contract they provided valuable test beds for Royal Aircraft Establishment (RAE). Photo: Blackburn, courtesy of Roger Jackson.

Bottom. A late contender was Short Brothers, who modified their S.A 1/2 Sturgeon to try and meet the Ministry's specification. Powered by two Armstrong Siddeley Mamba Turboprops, the airframe featured a 'droop' nose housing a radar and two operators. During test flying it proved to have poor handling qualities, and it failed to comply with the specification. It was also, as one observer put it, '...an aircraft so ugly that the very air surrounding it recoiled in horror, thus giving it serious problems in staying airborne.' Photo: Open Source (possibly R. Franks). >>

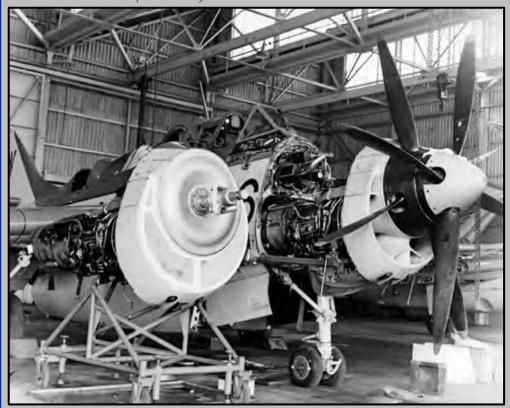
The Double Mamba (continued)

The Double Mamba power unit consisted of two Axial-Flow gas turbine engines arranged side by side and separately geared to co-axial, counter rotating propellers. The reduction gearing for both propellers is housed in a single built-up casing to which the port and starboard engines are attached. Each engine is provided with independent control, fuel, electrical and lubricating systems, so that either engine may be operated independently on the ground or in flight.

Left. The double Mamba engine assembly with associated transmission and propeller assembly was a unique design intended to give all the advantages of a twin but constrain the aircraft size to a single for shipborne operations. The entire assembly could be 'rolled out' of the aircraft on rails for easy access.

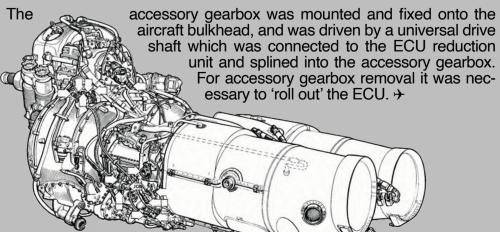
In preparation for 'rolling out', the yoke was fitted and supported by the nose undercarriage. The port and starboard servicing rails were attached to the yoke and aircraft, and set parallel and centre by adjustable tie-rods.

Roller and pinion assemblies were attached to lugs on both sides of the reduction casing. With the rollers and pinions seated on the rails and racks, and the ECU weight taken on the support blocks, you would then disconnect the ECU connections from the airframe. By manually turning the pinion turning bars the ECU would be rolled out for servicing.

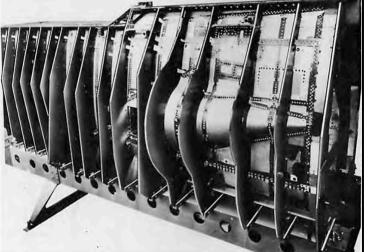
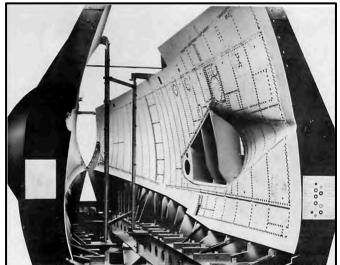
Left. Assembly Fixtures. Briefly, the assembly fixtures consist of a series of formers mounted on a rigid base, to a common datum. They are accurately lofted to represent the contour at a predetermined distance outside the actual aerodynamic outline. Attached to the formers is a skin or contour-template, the inside surface of which corresponds to the outside contour of the aircraft component. Right. This contour template is then accurately marked out, by special equipment, with details of rivets, facings, trim lines, cut-outs, doors and access panels etc., so the template also becomes a drilling template lofted in three dimensions.

Below. Marking Out. One disadvantage of

the conventional method of marking out, aside from its difficulty, was that no permanent record was retained for the purpose of checking or later modifications. Envelope Tooling not only ensures the accuracy of the marking out but leaves a permanent record for inspection, which can be checked before a component is built. Special equipment has been devised for marking out on the assembly fixture and the efficient use of this equipment is the basis of the whole process of Envelope Tooling. In the accompanying views, some of the special equipment can be seen in use.

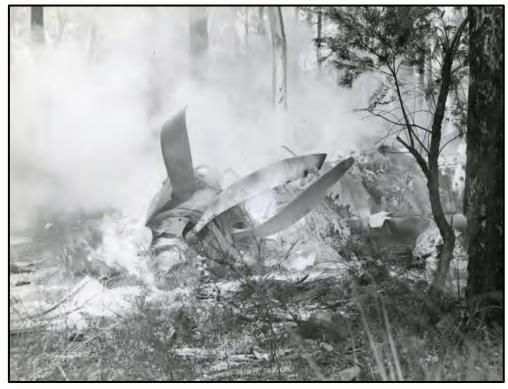
Above. Forgetting to engage the Flight Fine Pitch Stop(s) could have catastrophic results.

Getting back to the Gannet peculiarities, the second sting in its tail – which caused many accidents and injuries, including death - was a little thing called the Flight Fine Pitch Stop. Essentially, this was a pin which prevented each propeller from moving into the fully fine position when the throttles were retarded as for landing, unless the landing gear was down and locked. This stop was actuated (inserted) by the landing gear coming up, and removed by it on lowering for landing. When the propellers were allowed the full movement into the full fine position, they effectively presented two solid disks to the airflow, causing enormous drag and potential for uncontrollable loss of altitude. Of course, this was of little concern when at altitude or when within inches of the ground in the normal landing with the gear down. However, in the single engine configuration, this drag was not at all desirable - so there were two Flight Fine Pitch Stop Override (FFPSO) switches in the cockpit with which the withdrawal of these pins (one on each propeller) was prevented, either individually or together when the landing gear was lowered. Of course, when attempting a single engine landing, the lack of this drag in the final landing phase (assuming the pilot had remembered to make the FFPSO switches) could result in a float before touchdown. This was of no consequence when landing on a runway – but caused untold difficulties in the final phase of a deck landing! It was invariably this, in association with possible deck movement, which caused the aircraft to float over the wires and BOLTER!

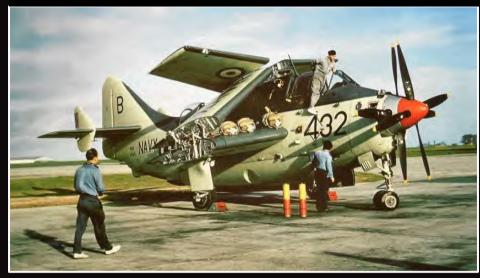
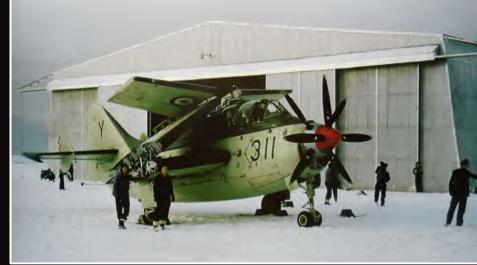
Above: Snow at Culdrose (Cornwall, UK) is unusual as its proximity to the west coast usually brings wetter but milder weather. The winter of 1955/56 was an exception, as the images show. From L to R: Two shots of Gannet 311 which is shown above (right) starting up. The black smoke is from the cartridge used to spin up one of the two engines. The second engine was then started by 'windmilling' the prop in the wash of the first. Images 3 and 4 depict ground crews amusing themselves in the snow. All pictures via Jeff Chartier.

The Double Mamba had a twin-breech cartridge starter fitted to each engine. The starter motor was a small impulse-type turbine geared to the engine and driven by high-velocity gases from a burning cordite charge cartridge, which was initiated by an electrically-fired detonator. A safety bursting disc was provided in the gas path to limit any over-pressure that might occur during the starting cycle, and these discs did burst occasionally, particularly when using certain batches of cartridges which obviously had too much "kick". If time permitted, the burst disc was removed and replaced with a serviceable item; the alternative was to start the other engine (if not already running), go to full power and then windmill-start the engine in question. In the unlikely event that neither of these options was available, a two shilling (20 cent) coin served perfectly as a replacement (and probably un-burstable!) disc.

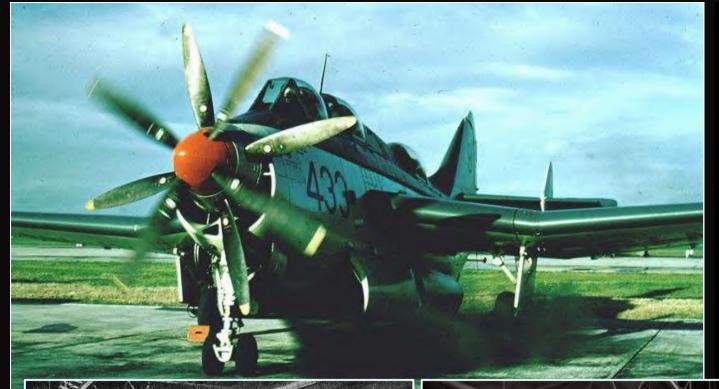
Above: A great shot of Gannet 433(B) doing an engine start at Culdrose. Barry White remembers the difficulty in installing starter cartridges in the Sea Venom and Gannet. The sea Venom was not too bad as the starter breech was situated just behind the cockpit. The Gannet was a whole different story being up high, just aft of the pro-pellers. He recalled it was bad enough when the breech was cold, but distinctly interesting loading fresh cartridges into a hot breech whilst clinging onto the aircraft via a couple of hand/toe holds. The Gannet was also capable of being airstarted, using a ground-based compressor (see page 61 of the Pilots Notes). It was seldom used in the RAN except, perhaps, for the occasional foray to shore airfields to collect stores and personnel.

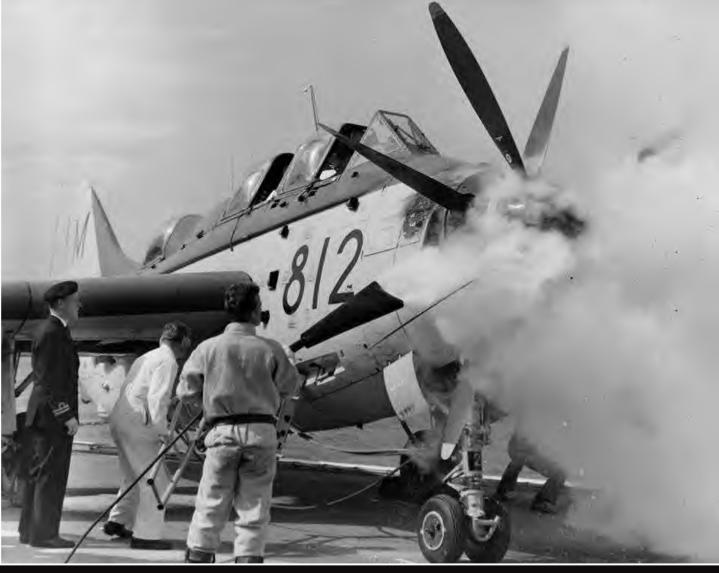
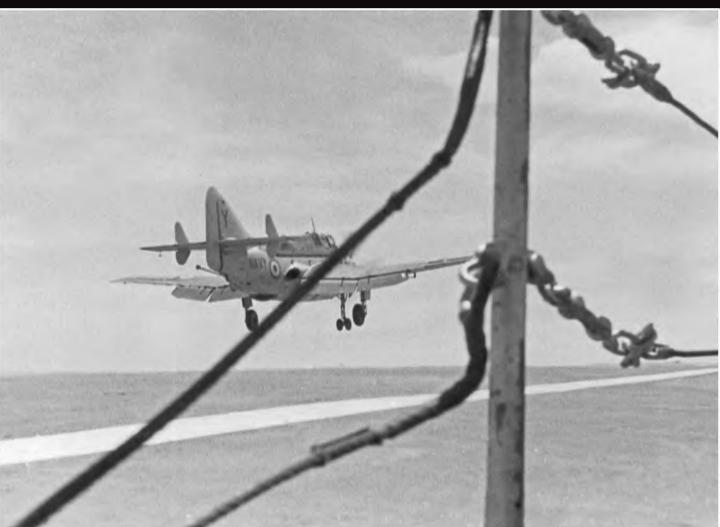
Above: A visually pleasing shot of a Gannet doing a touch and go on Melbourne. **Above Left:** An unusual shot of the bomb bay, which could hold two torpedoes, bombs or depth charges. (Images via Jeff Chartier).

Middle Left: Oops! A jack collapse during servicing at NAS Nowra caused substantial damage to this Gannet. Lower Left. An unusual shot showing the underside of a Gannet in flight. Note the size of the bomb bay and the retractable radar transducer just aft of it. Both images via Jeff Chartier. Below Right: A visitor to RAAF Point Cook in late 1965 (possibly XA343 in October), this Gannet attracted the attention of a Midshipman who sits in the centre (Observer's) cockpit.

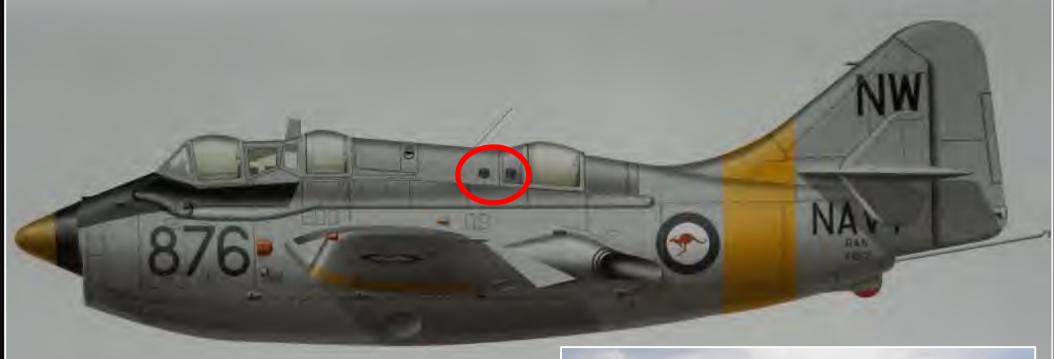
Above and Right. A little known fact about the Fairey Gannet T Mk2 trainer is that it was a four-seater. The additional seat was located in the rear cabin, positioned forward of the rear seat. This extra seat was fitted with a normal harness and faced aft - the two small, round windows in the fuselage indicate its position. Between the seats was a netting type cargo holder, with quick release fittings, suitable for non-ordnance items such as mail or other light objects. In the event of an emergency the occupant of the 'spare seat' would have had great difficulty extracting themselves, which may explain why no one can remember it being used.
